**Huntingdon Road
Vaughan, ON**

**Fluvial Geomorphological
Assessment
and
Meander Beltwidth
Assessment**

August 21, 2017

**RE: Huntingdon Road, Region of York, ON
 Fluvial Geomorphological Assessment and Meander Beltwidth Assessment**

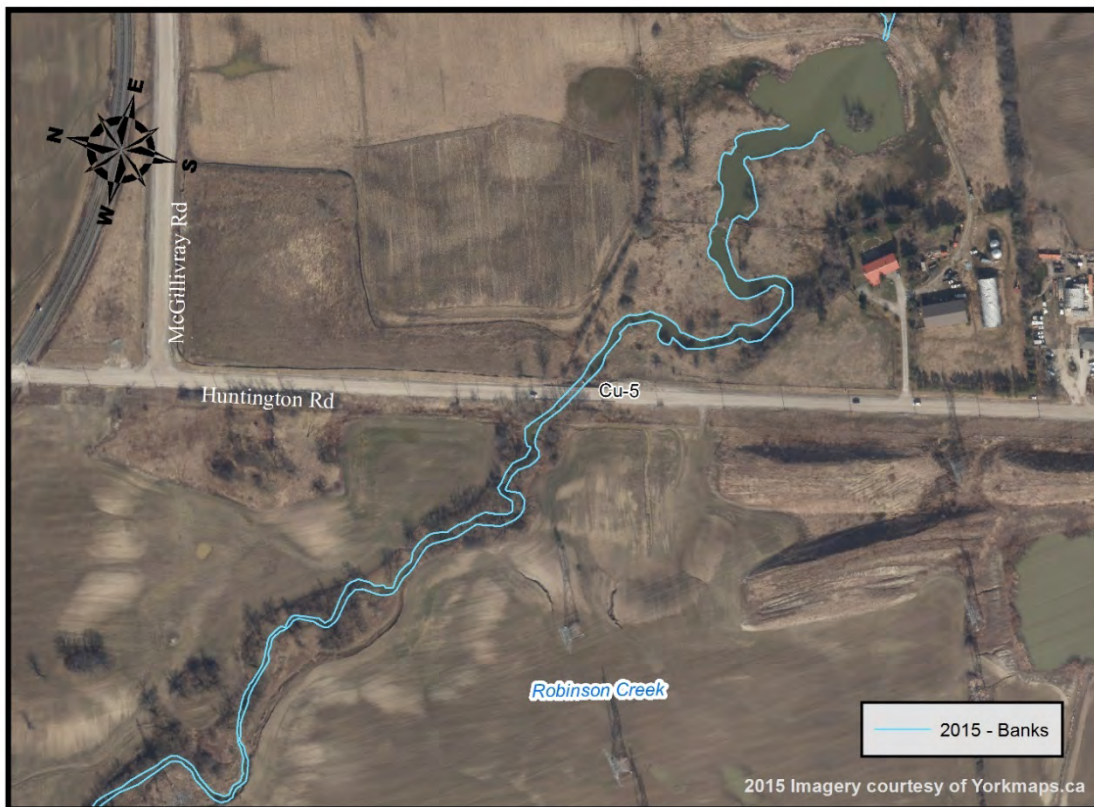
Figure 4: Aerial View of Cu-5 on Rainbow Creek

This crossing just south of Major Mackenzie Drive and McGillivray Rd (see Figure 4) is the largest of the crossings being observed. This culvert conveys Robinson Creek through Huntingdon Rd. The upstream reach shows proper channel features and has some riparian buffer but is close to agricultural lands in a few areas. In the areas where the stream comes close to the fields there are eroding and unstable banks. Some undercut banks were observed in this reach. The downstream reach runs through active grazing lands. Around 300m downstream of the culvert the stream flows into a pond which is also in active grazing lands. The downstream reach shows signs of cattle crossing creating a wide and slow-moving channel.

Approximately 200 metres were surveyed for this study. Three cross sections were surveyed in this reach, all three on the east side (upstream). The channel showed low width-to-depth ratio (<12) and is slightly entrenched. The average bankfull slope is 0.0028 m/m, and the bankfull width and average depth were noted to be 5.24 m and 0.48 m. The substrate in this reach is focused on gravels. A sieve sample was completed for the reach and the results show 4% silt, 20% sands, 56% gravels and 20% cobbles. Rosgen classification for this reach is determined to be a C4 channel type. Survey results can be seen in Table 1.

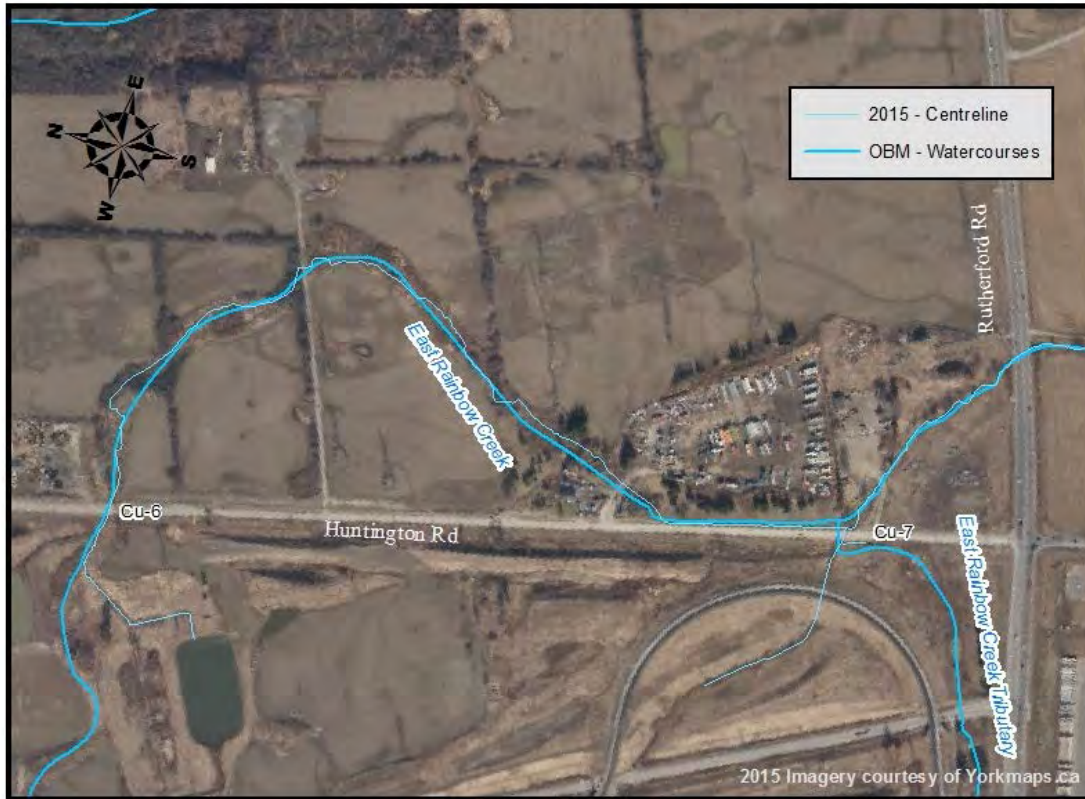
Figure 5: Aerial View of Cu-6 on East Rainbow Creek and Cu-7 (Rainbow Creek Trib)

This crossing is located halfway between Major Mackenzie Drive and Rutherford Rd (See Figure 5). This culvert conveys East Rainbow Creek through Huntingdon Rd. The upstream and

Approximately 175 metres of channel were surveyed along with three cross sections to determine the typical channel geometry. The overall channel has a low width-to-depth ratio and is slightly entrenched. The average bankfull slope through the whole study area is 0.0031 m/m, and the average bankfull width and depth were noted to be 1.47m and .22 m. The substrate in this reach ranges from silt to small gravel. The sieve sample for this reach reveals that 54% of the substrate is silt and 40% is sand while 6% is gravel. The banks are typically made up of highly erodible soils. Rosgen classification for this reach is determined to be an E6 channel type. Survey results can be seen in Table 1.

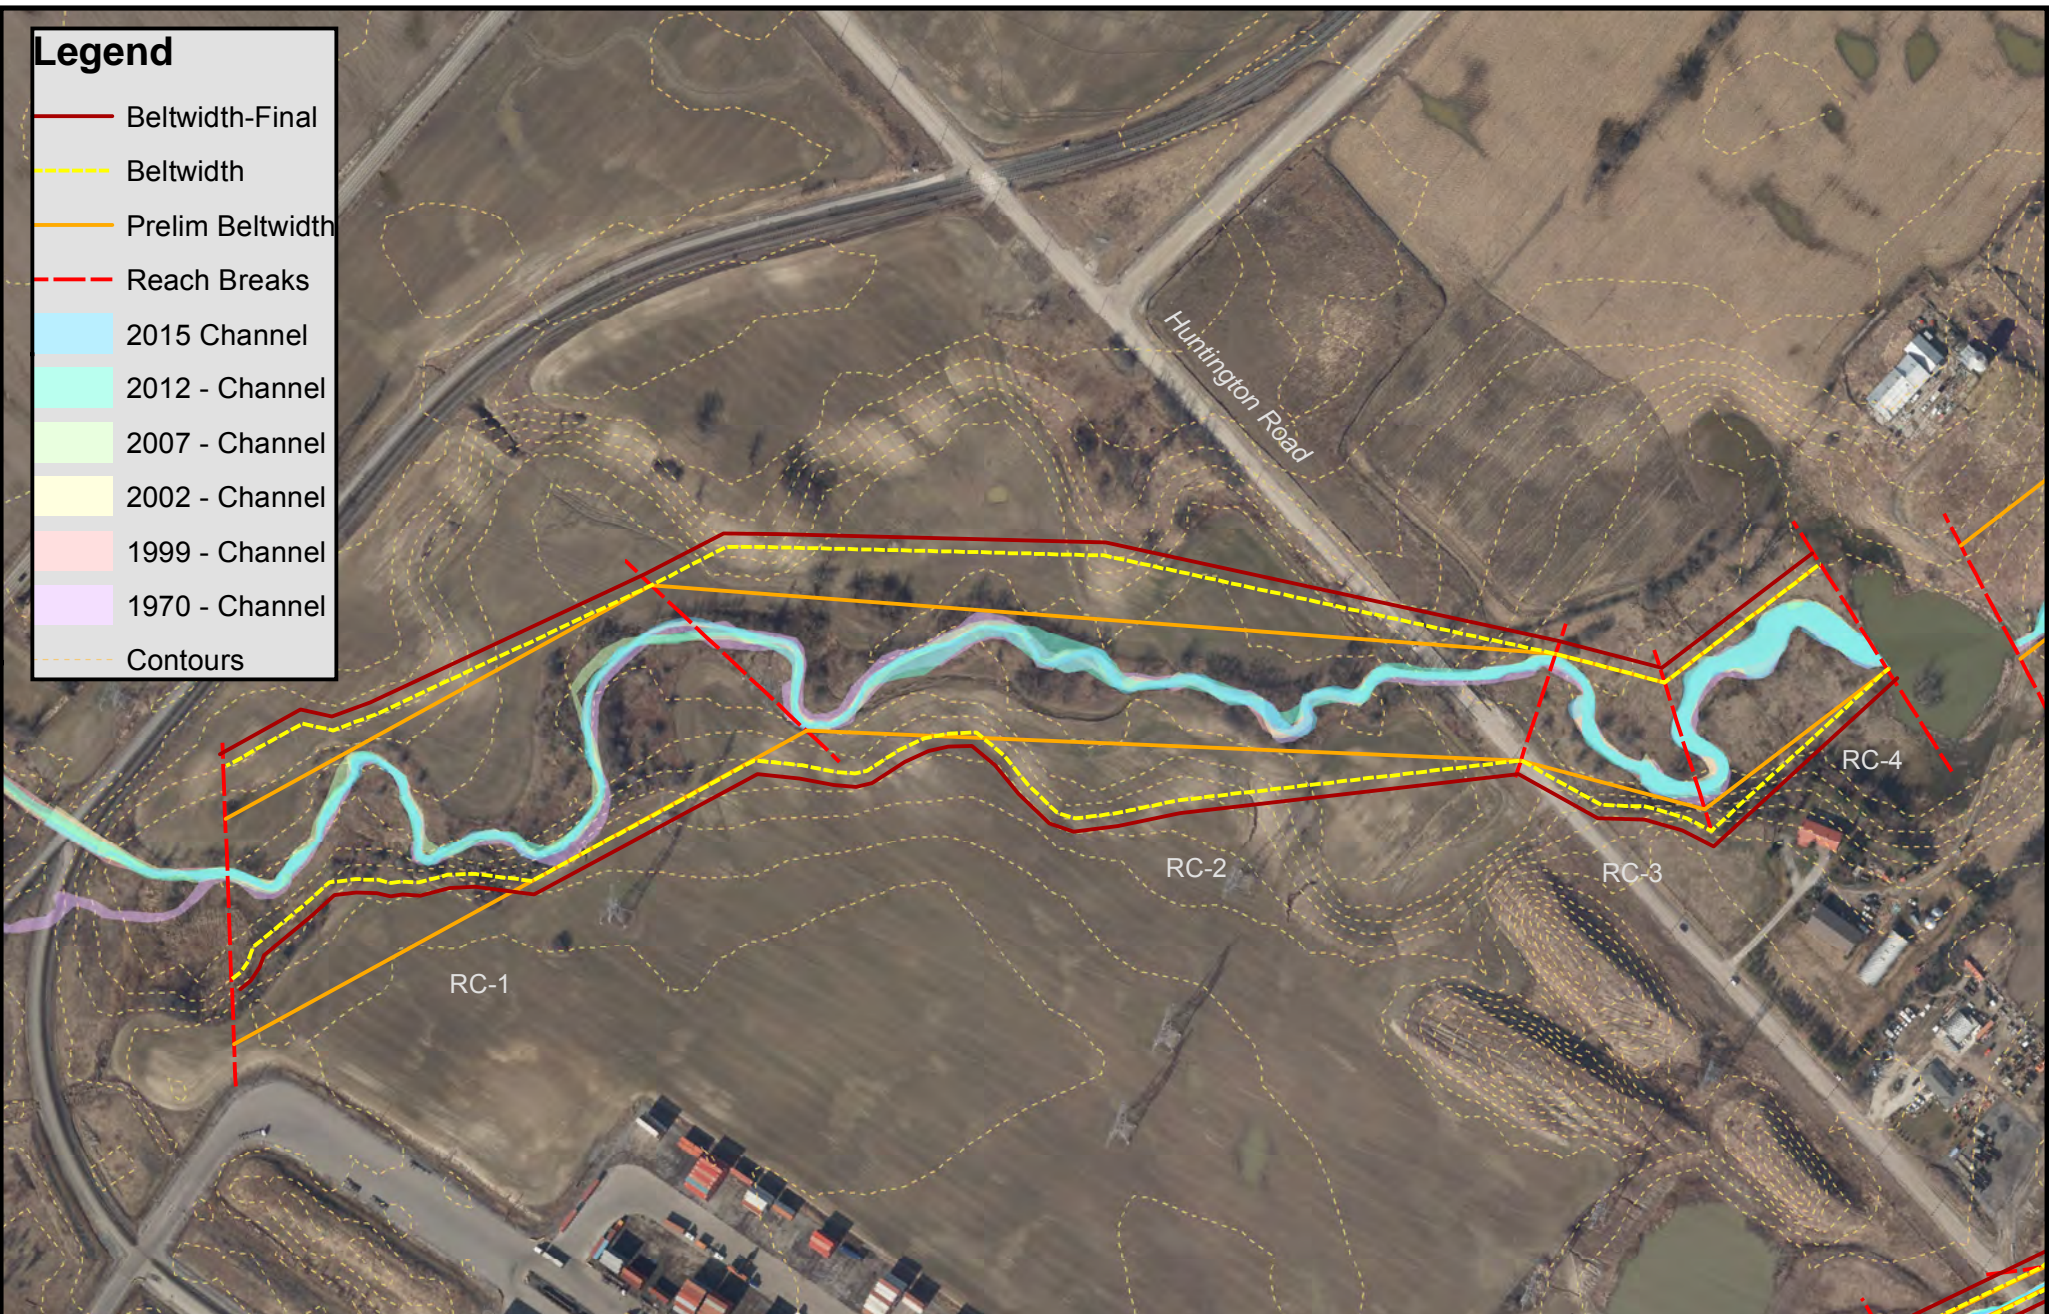
Meander Beltwidth Assessment - Robinson Creek

All six delineated reaches of Robinson Creek in the vicinity of Huntingdon Road are confined by valley walls as indicated by the 1 m contours obtained from York Region. Between 1970 and 2015, no change in meander axis was noted. Because of the confined nature of Robinson Creek, the application of the tangential meander belt width was not an accurate means to determine the extent of final beltwidth. The meander boundaries were adjusted to account for the irregularity in the valley walls and were placed at an average distance between the top and bottom of valley walls where applicable. The meander beltwidth for this creek is shown in Figure 9 (attached). Further, to account for the fact that the existing meander belt does not necessarily reflect a quasi-equilibrium form, a factor of safety of 10% is added to determine the final meander beltwidth. Along the Huntingdon crossing, the final meander beltwidth was determined to be 126.4m.

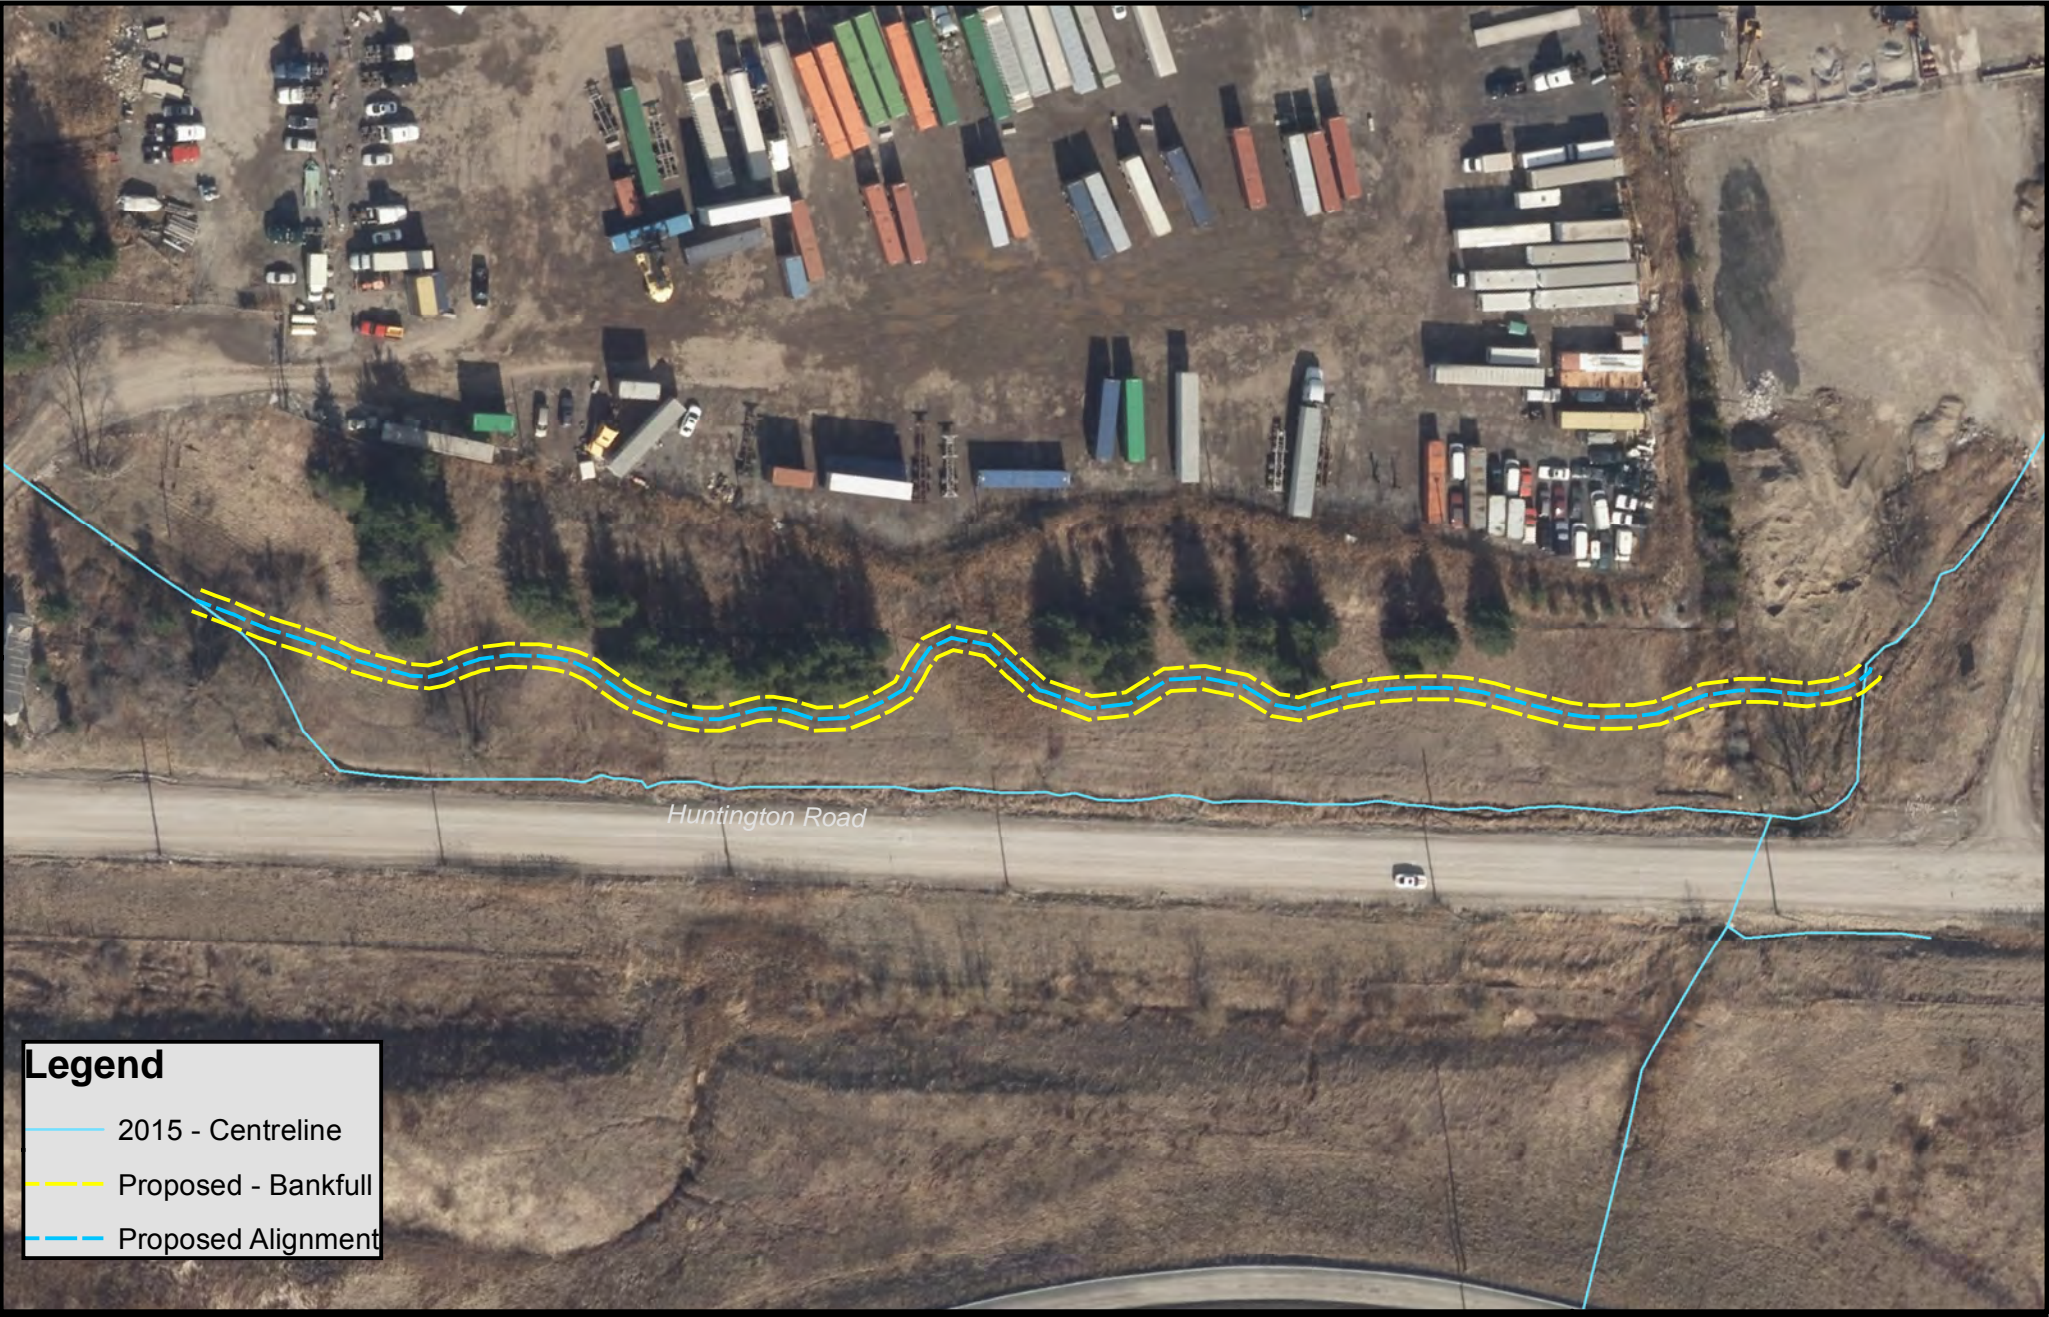
<h3>Huntington Road</h3> <p>Vaughan, Ontario</p>	Figure No.:	Date:
	12	May 31, 2016
<p>Proposed Realignment (Conceptual)</p>	Checked By:	Drawn By:
	EG	CB

- The creek realigned is approximately 260m long;
- The recommended alignment is at least 12m away from the existing road edge of pavement;
- The creek is to be a series of riffles and pools with a bankfull width of 3.4m;
- The planview alignment of the creek is designed such that as much as possible, the existing trees are to be left standing.

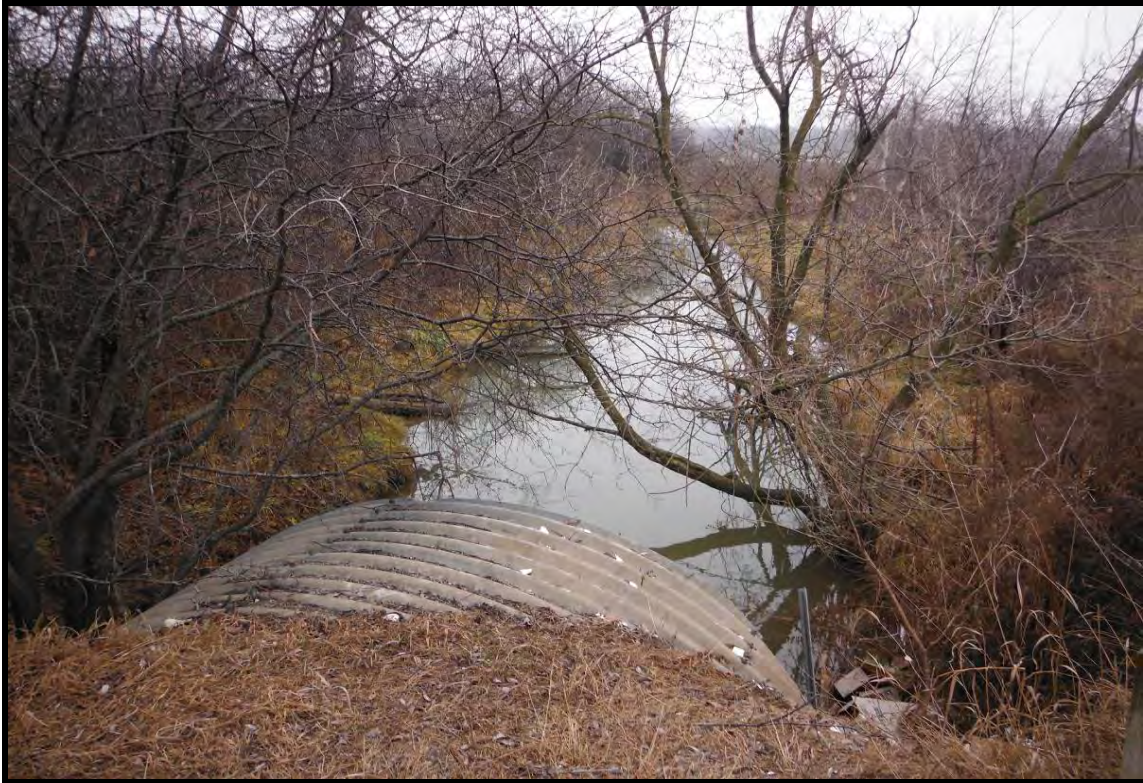
PHOTOGRAPH NO.: 7 - Culvert 5
FROM: Downstream end of culvert
LOOKING: Downstream at channel bed
COMMENT: Active grazing lands

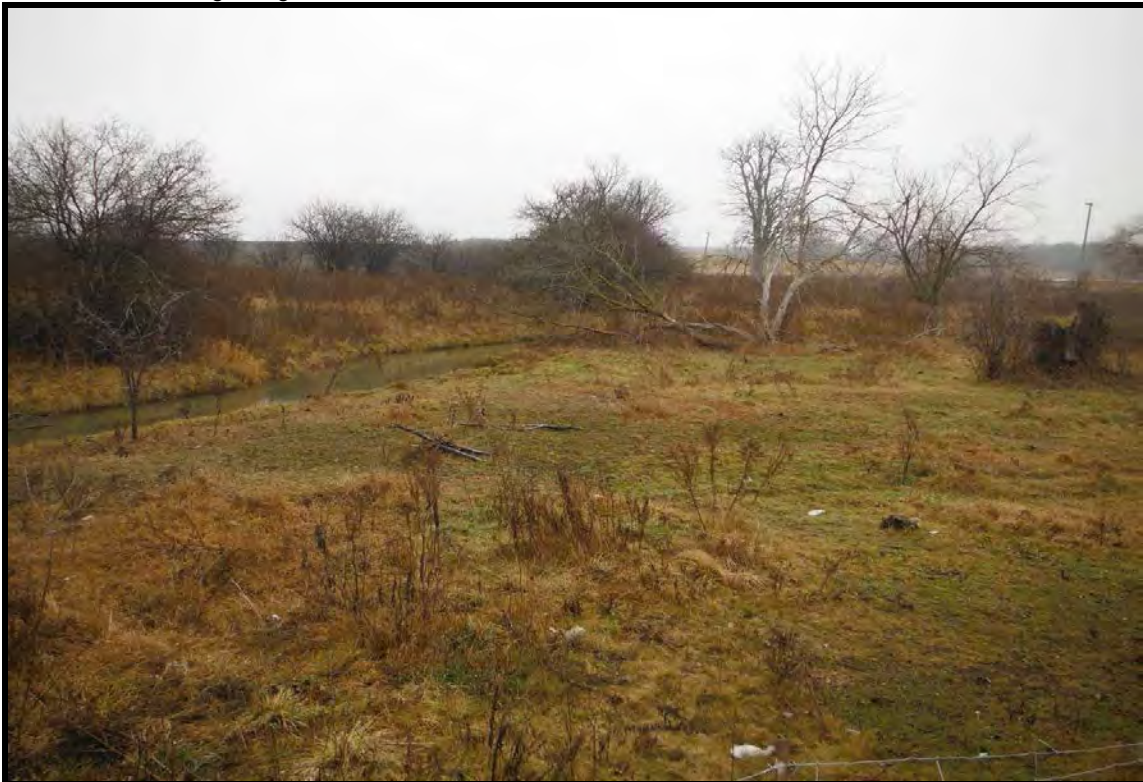
PHOTOGRAPH NO.: 8 - Culvert 5
FROM: From road
LOOKING: Downstream at channel through grazing lands
COMMENT: Stream flows into online pond 50m outside of picture

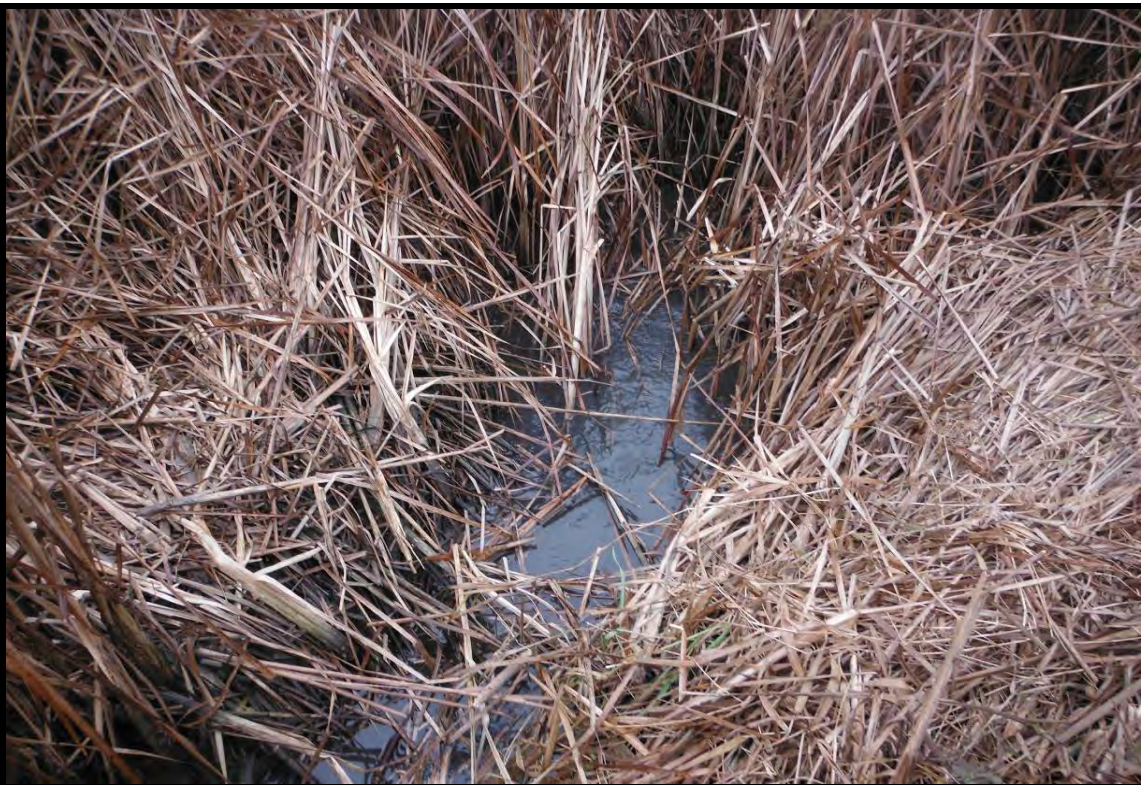
PHOTOGRAPH NO.: 12 - Culvert 6
FROM: Downstream end of survey
LOOKING: Upstream at channel
COMMENT: Typical shape of channel through reach
