# Rainbow Creek Master Plan Update Study

THE CITY OF VAUGHAN

COLE ENGINEERING GROUP LTD.

JUNE 2014

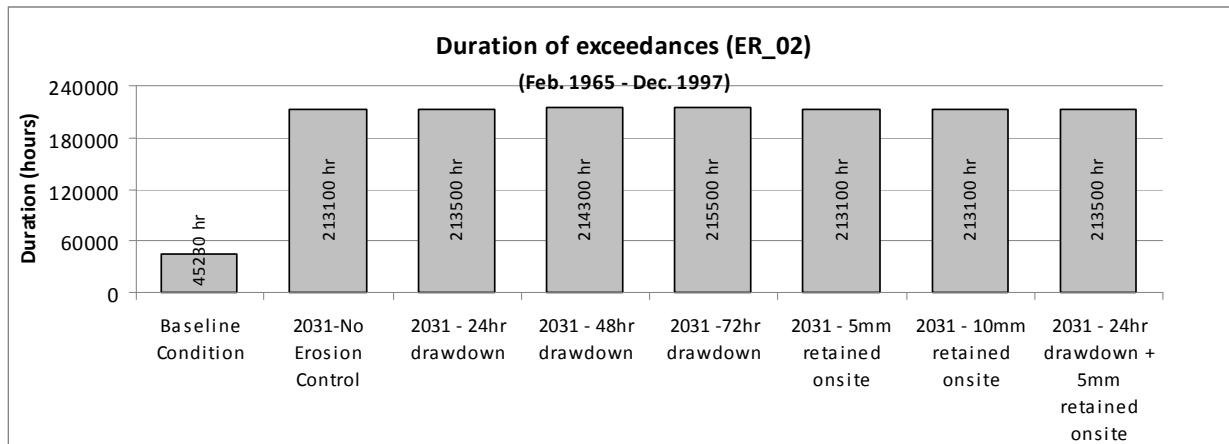
**Figure 5-1 Erosion Threshold Site 02**

The results of this analysis are presented graphically for each erosion site as shown in **Figure 5-1** through **Figure 5-11**.

These results show that in general the most beneficial erosion control criteria is the on-site retention of the first 10 mm of rainfall. Although this does not reduce the duration of erosive flows to pre-development levels it does provide the greatest overall reduction in the duration of erosive flows. Given the low erosion thresholds in much of the Creek, it is not possible to reduce duration of post-development erosive flows to pre-development levels. It was also found that in many areas that using a 24, 48 or 72-hour drawdown time for the first 25 mm of rainfall would lengthen the time that erosive flows were present in the Creek. This occurs when the erosion threshold in the Creek is low, so the release rate required to achieve a longer drawdown time is still greater than the erosion threshold. In these cases the longer draw down time results in a longer period with erosive flows. The on-site retention of 5 mm of rainfall provides a reduction of erosive flows that is almost equal to that achieved through the on-site retention of 10 mm. Given the difference in cost and the minimal benefit in terms of reducing hours of erosive flows it is recommended that 5 mm onsite retention be the criteria for erosion control in Rainbow Creek.

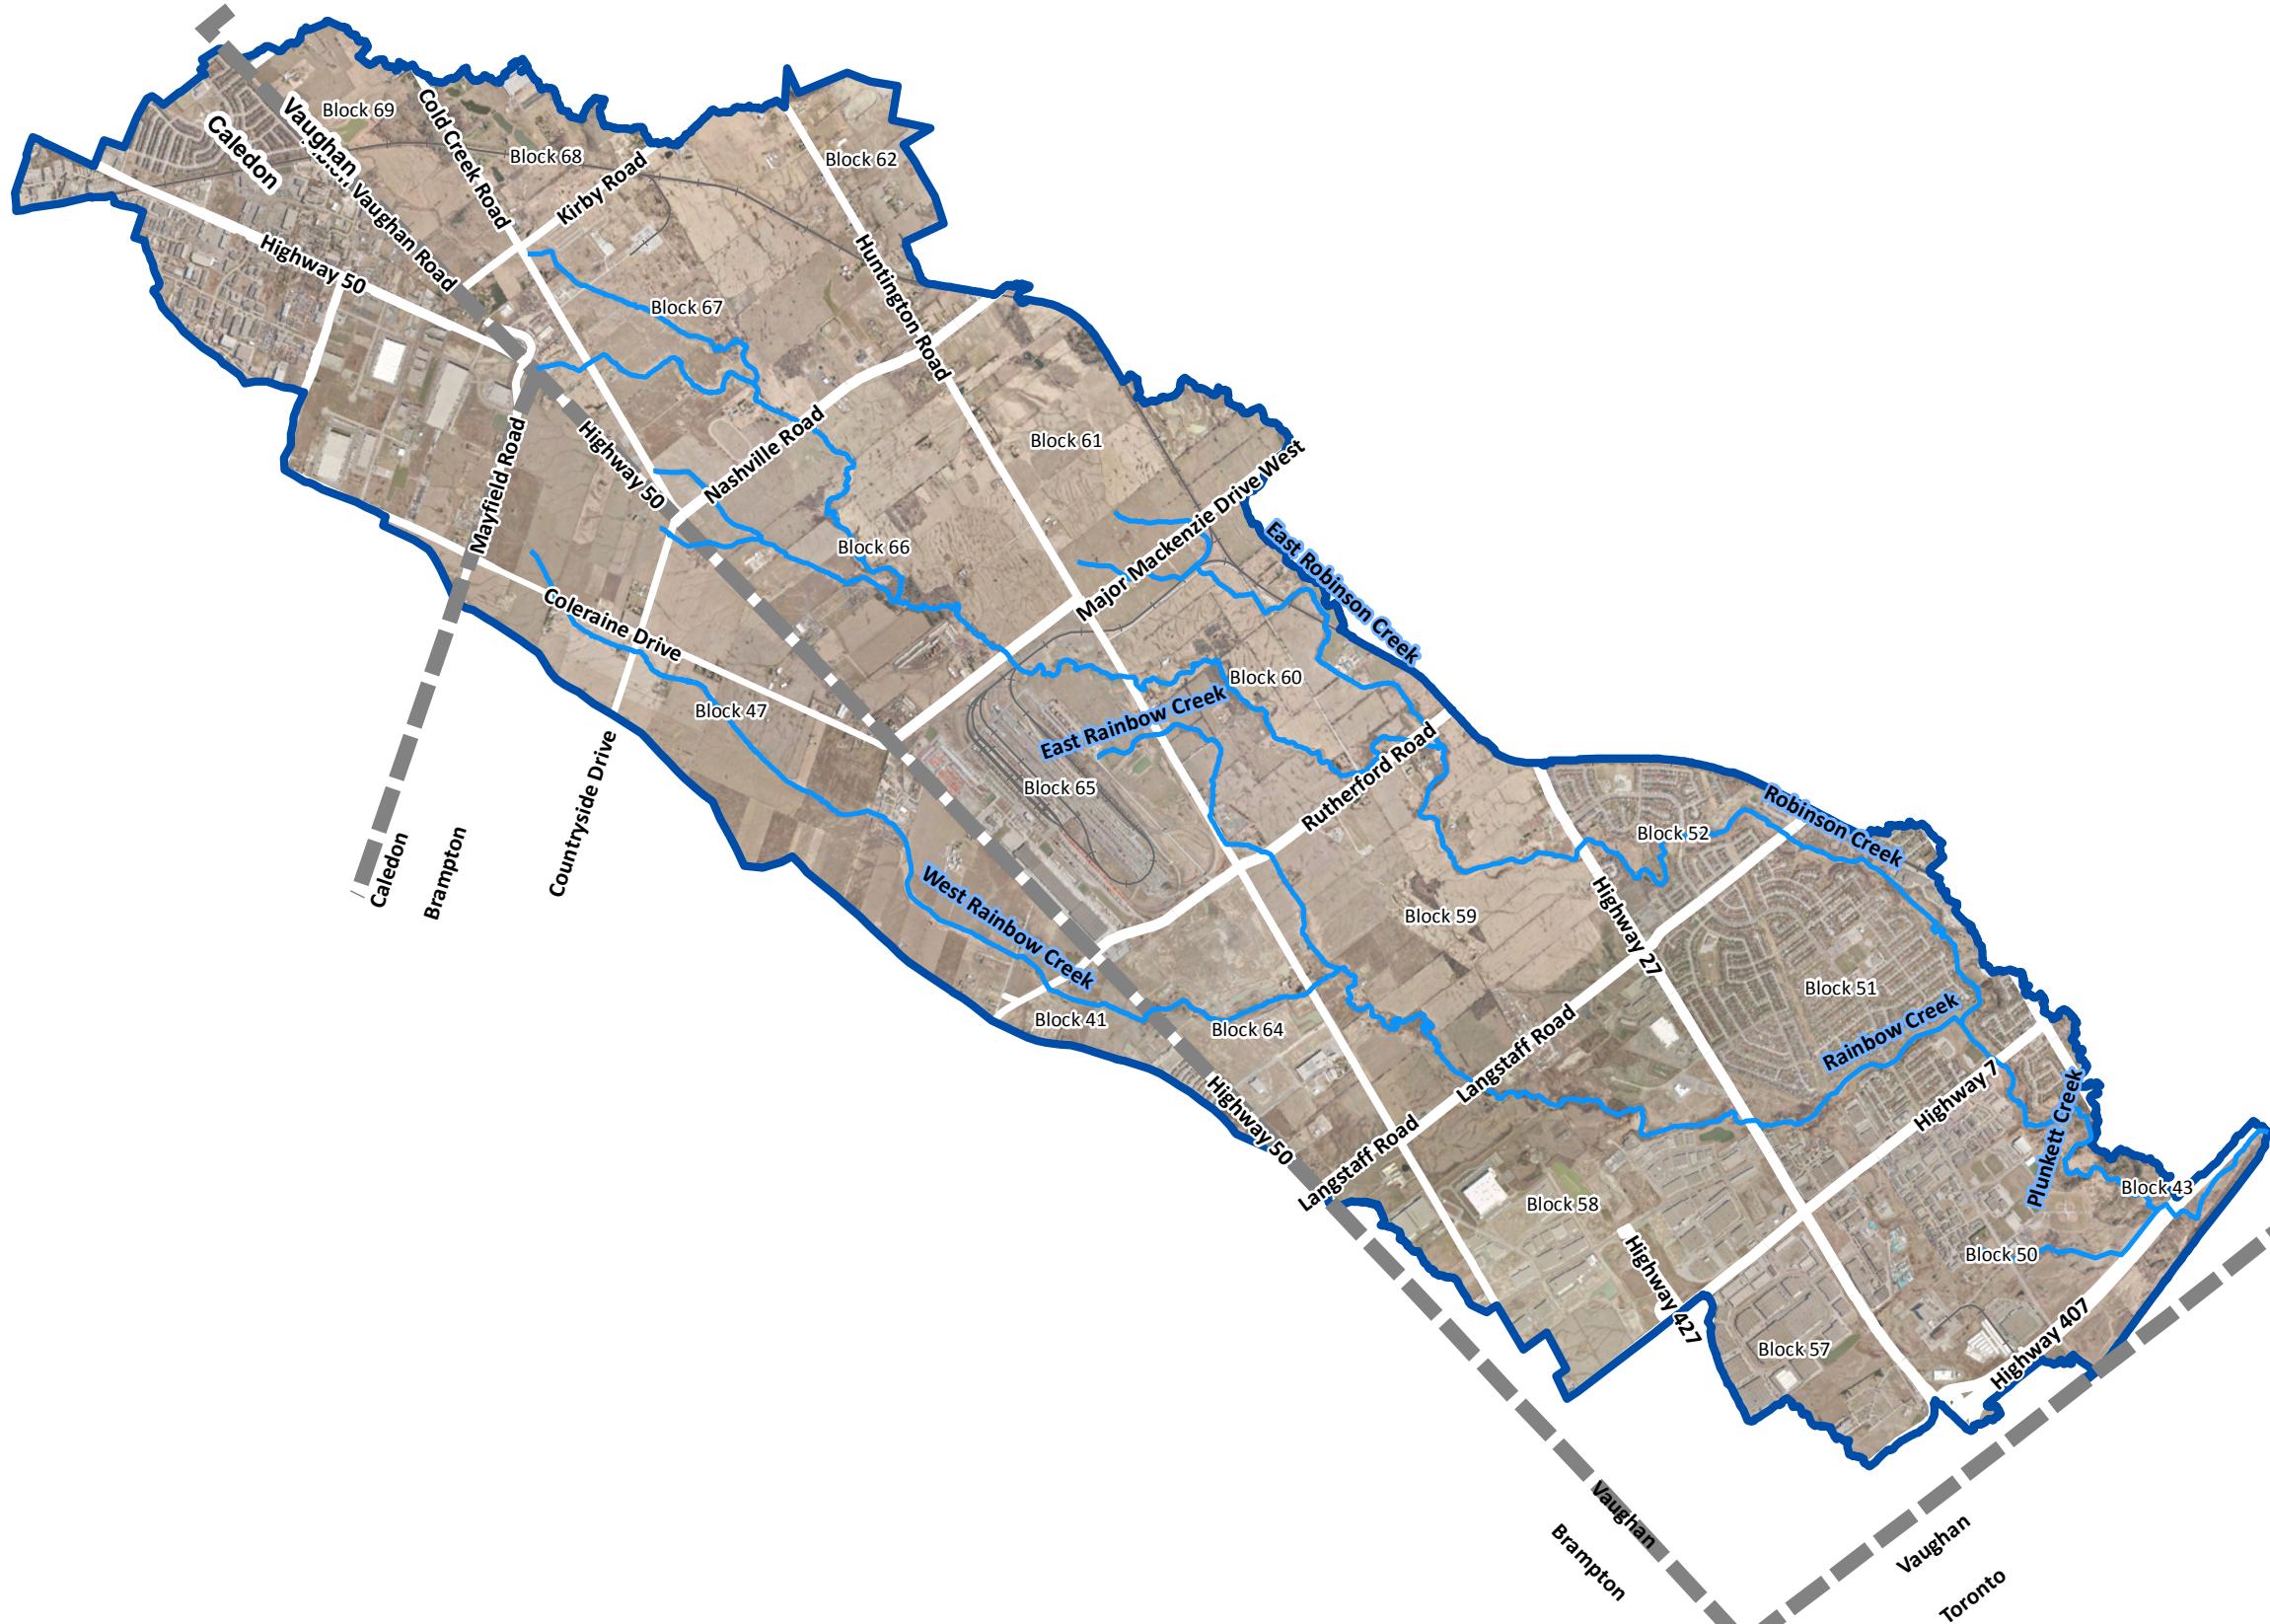
RC-2

# Existing Conditions

The baseline scenario is used to determine the current or acceptable conditions in a watershed. The baseline scenario for the Rainbow Creek Watershed is a combination of existing land use (**Figure RC-2** following the report) and development approved in the previous City of Vaughan Official Plan. This is consistent with the baseline scenario used in the Draft Humber River Model. The land use used for the baseline condition is shown on **Drawing LU-1**, located in **Appendix A**.

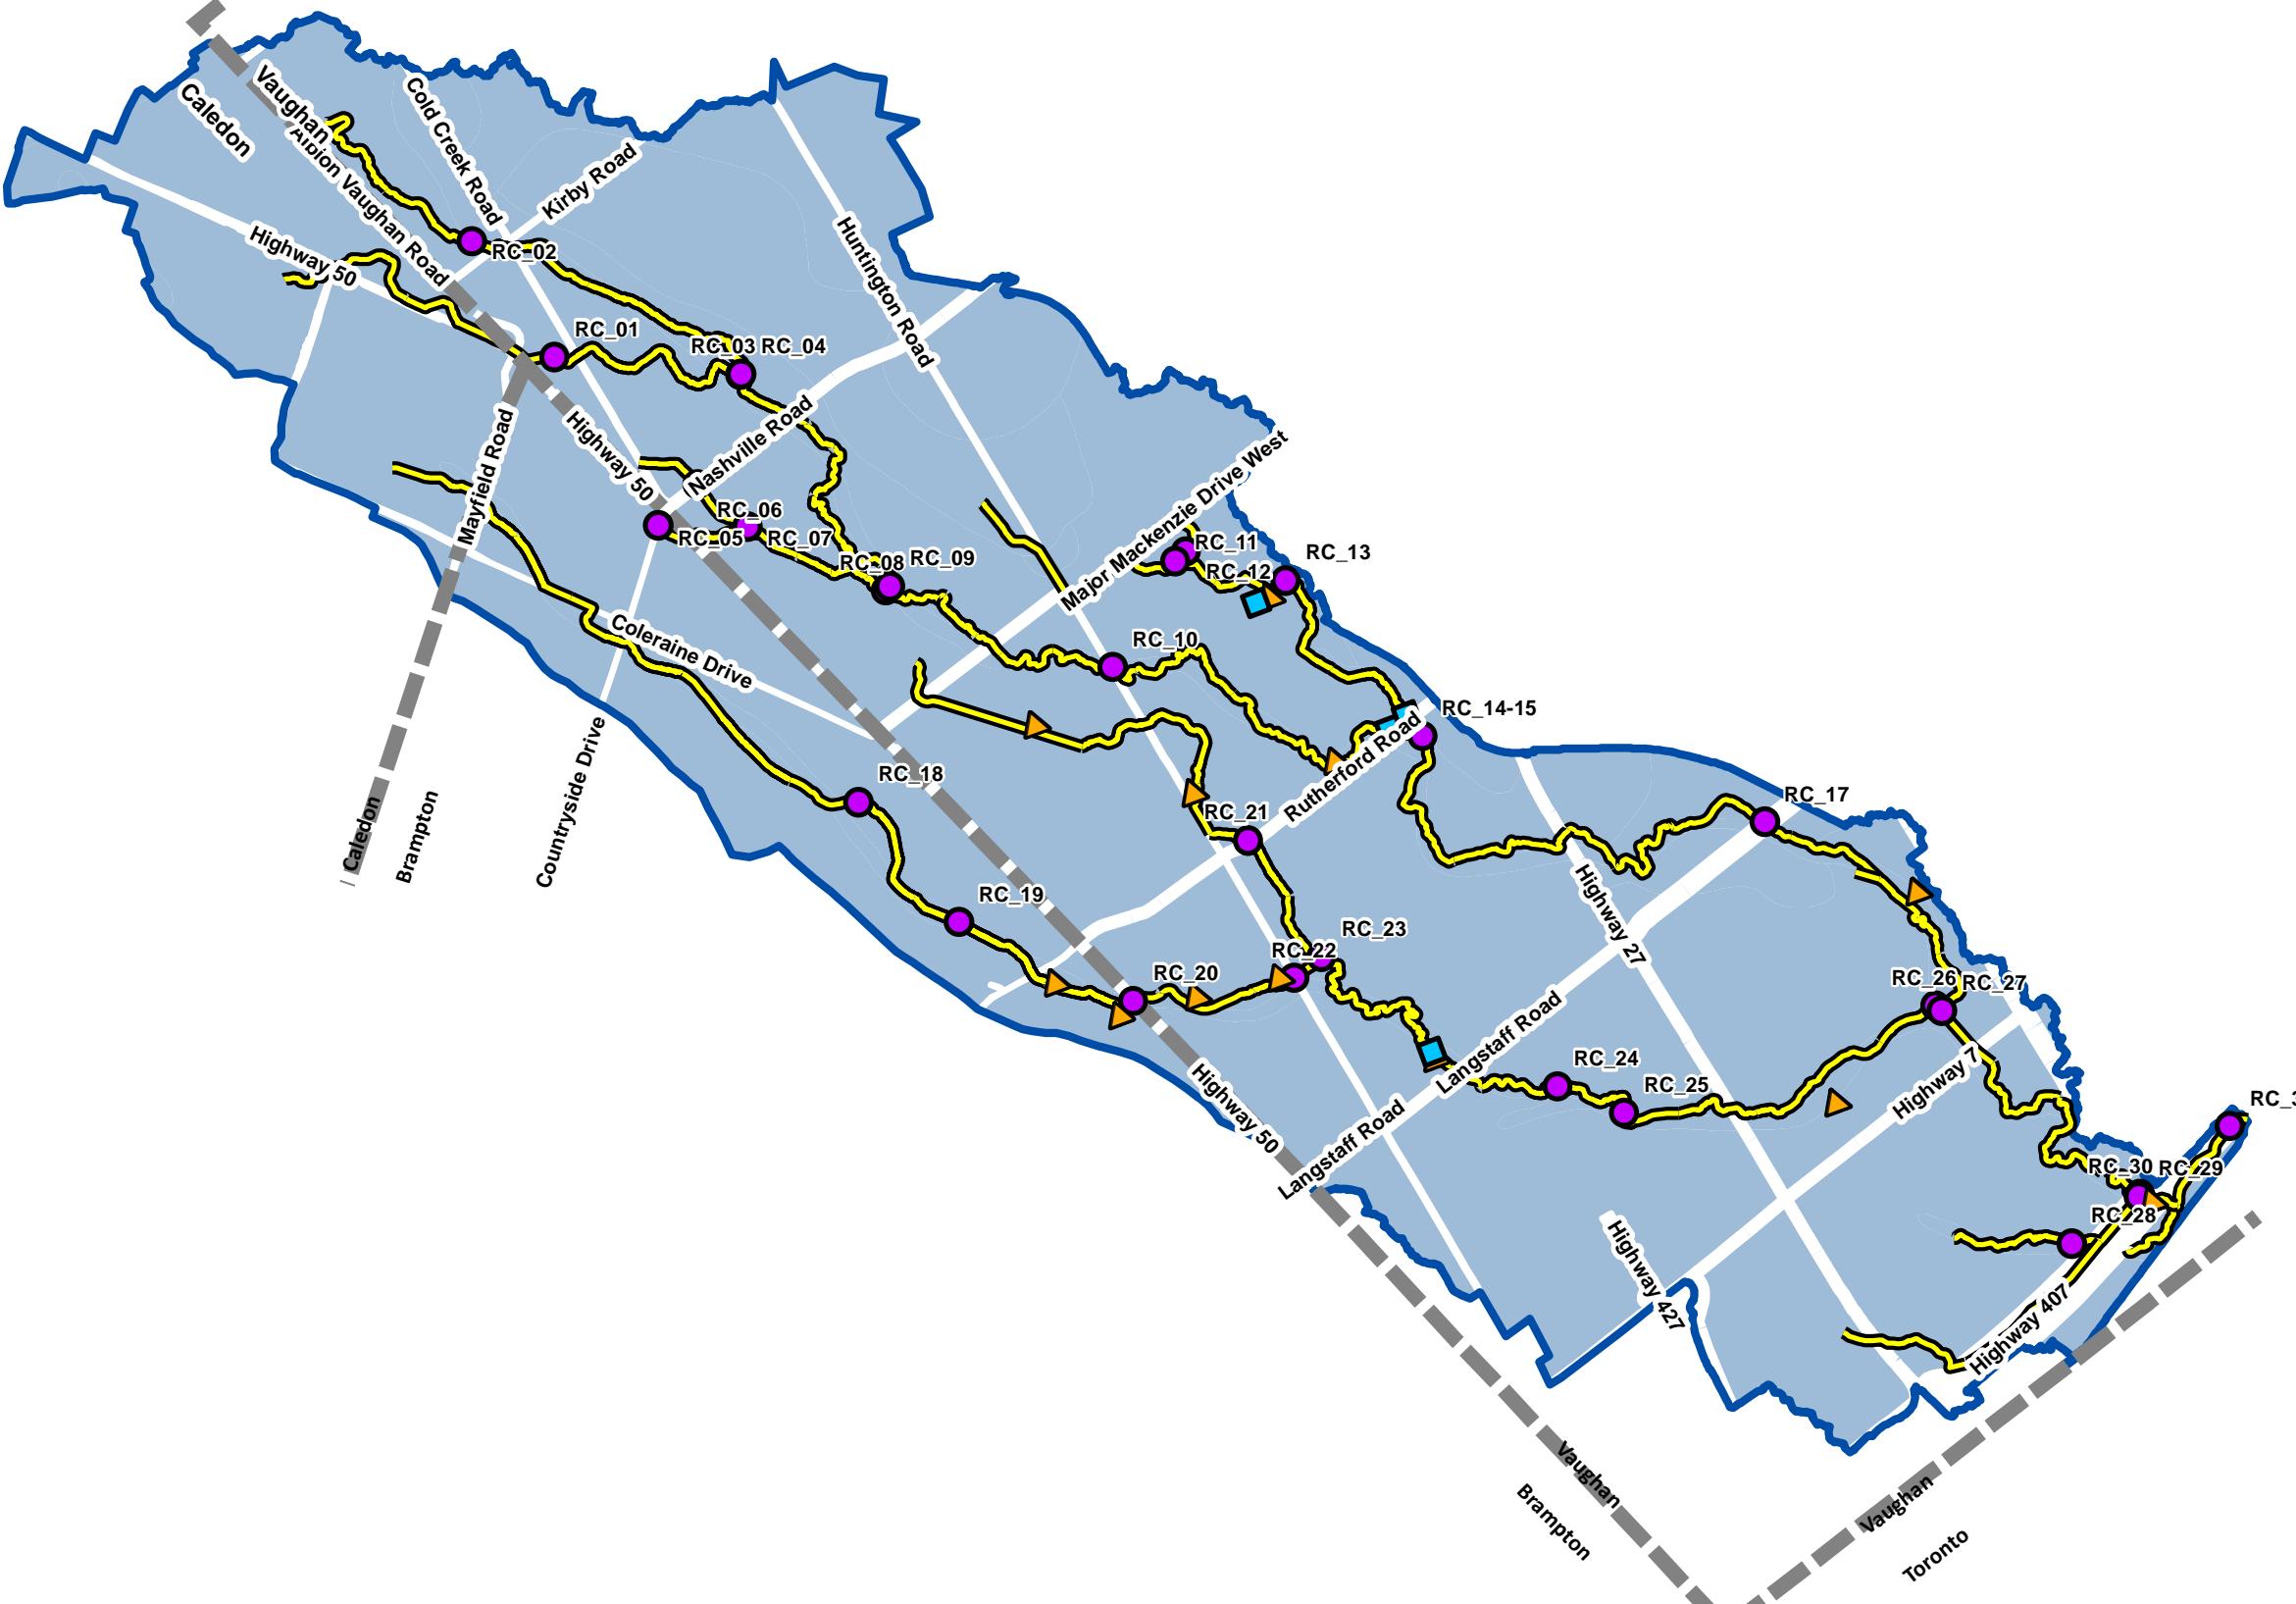
FIGURE  
RC-4

# Flood Susceptible and Historic Flooding Areas

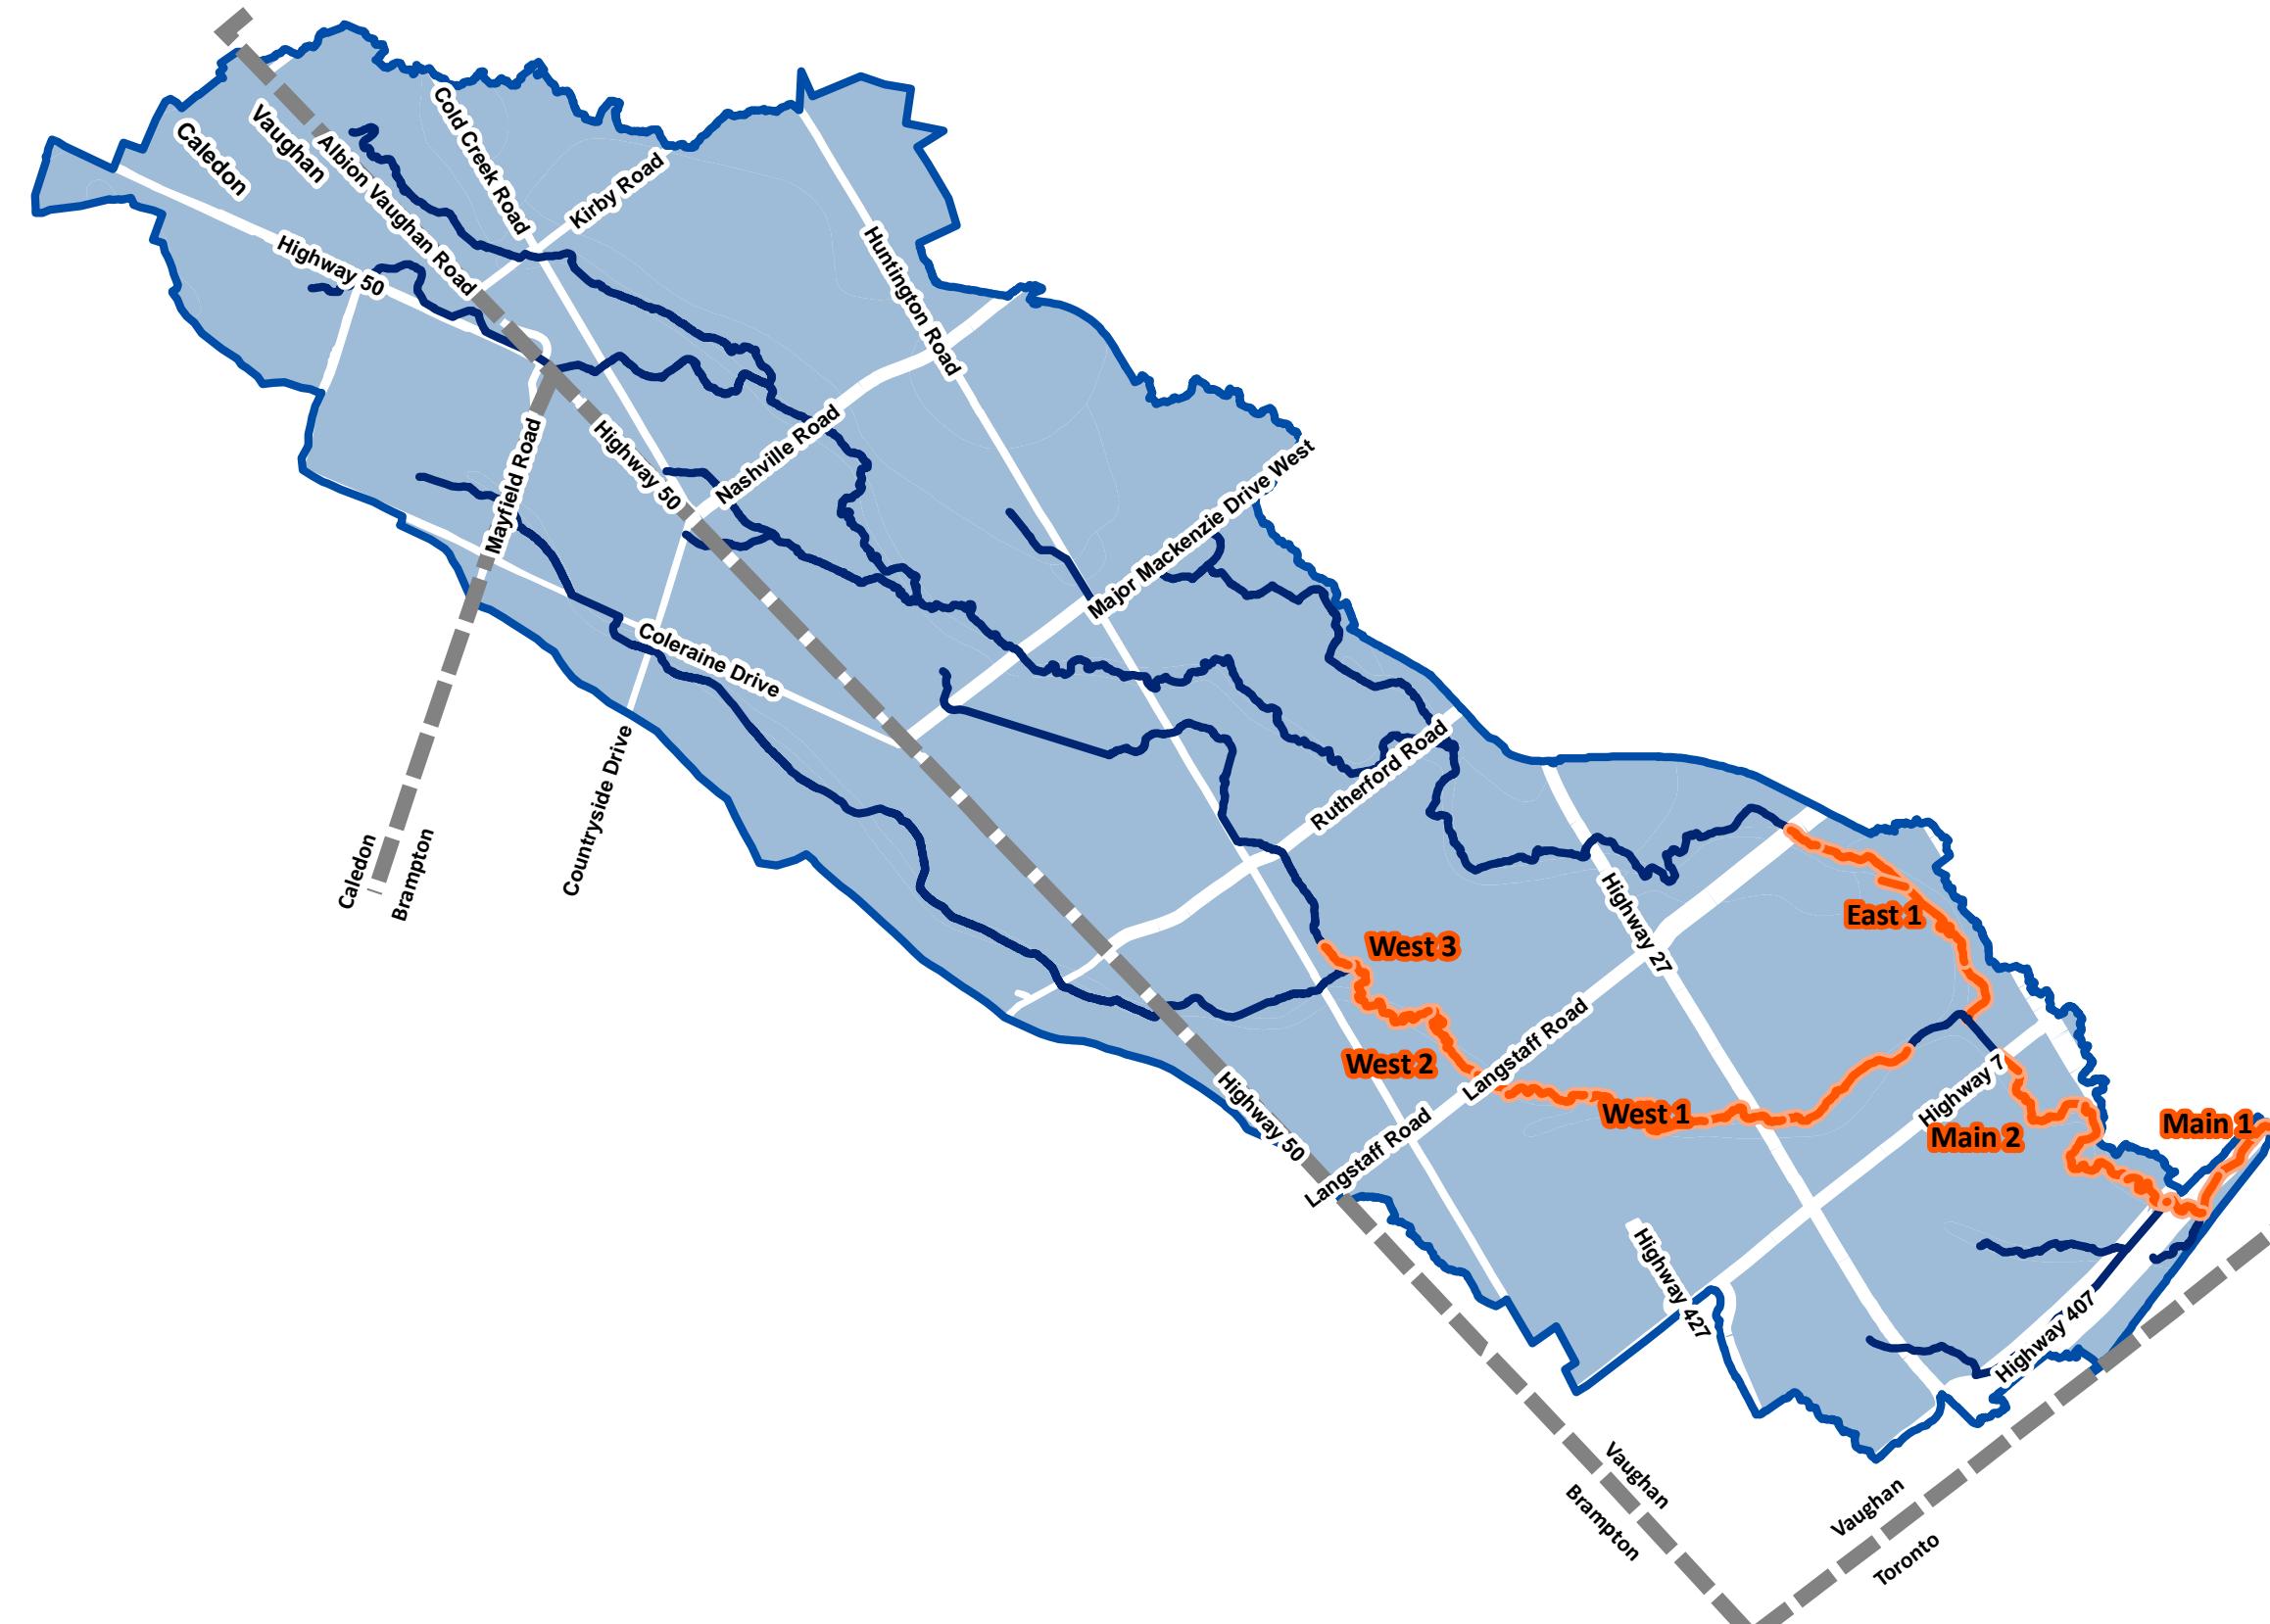
FIGURE  
RW-1

# Recommended Erosion Works

Locations of  
Recommended Erosion Works

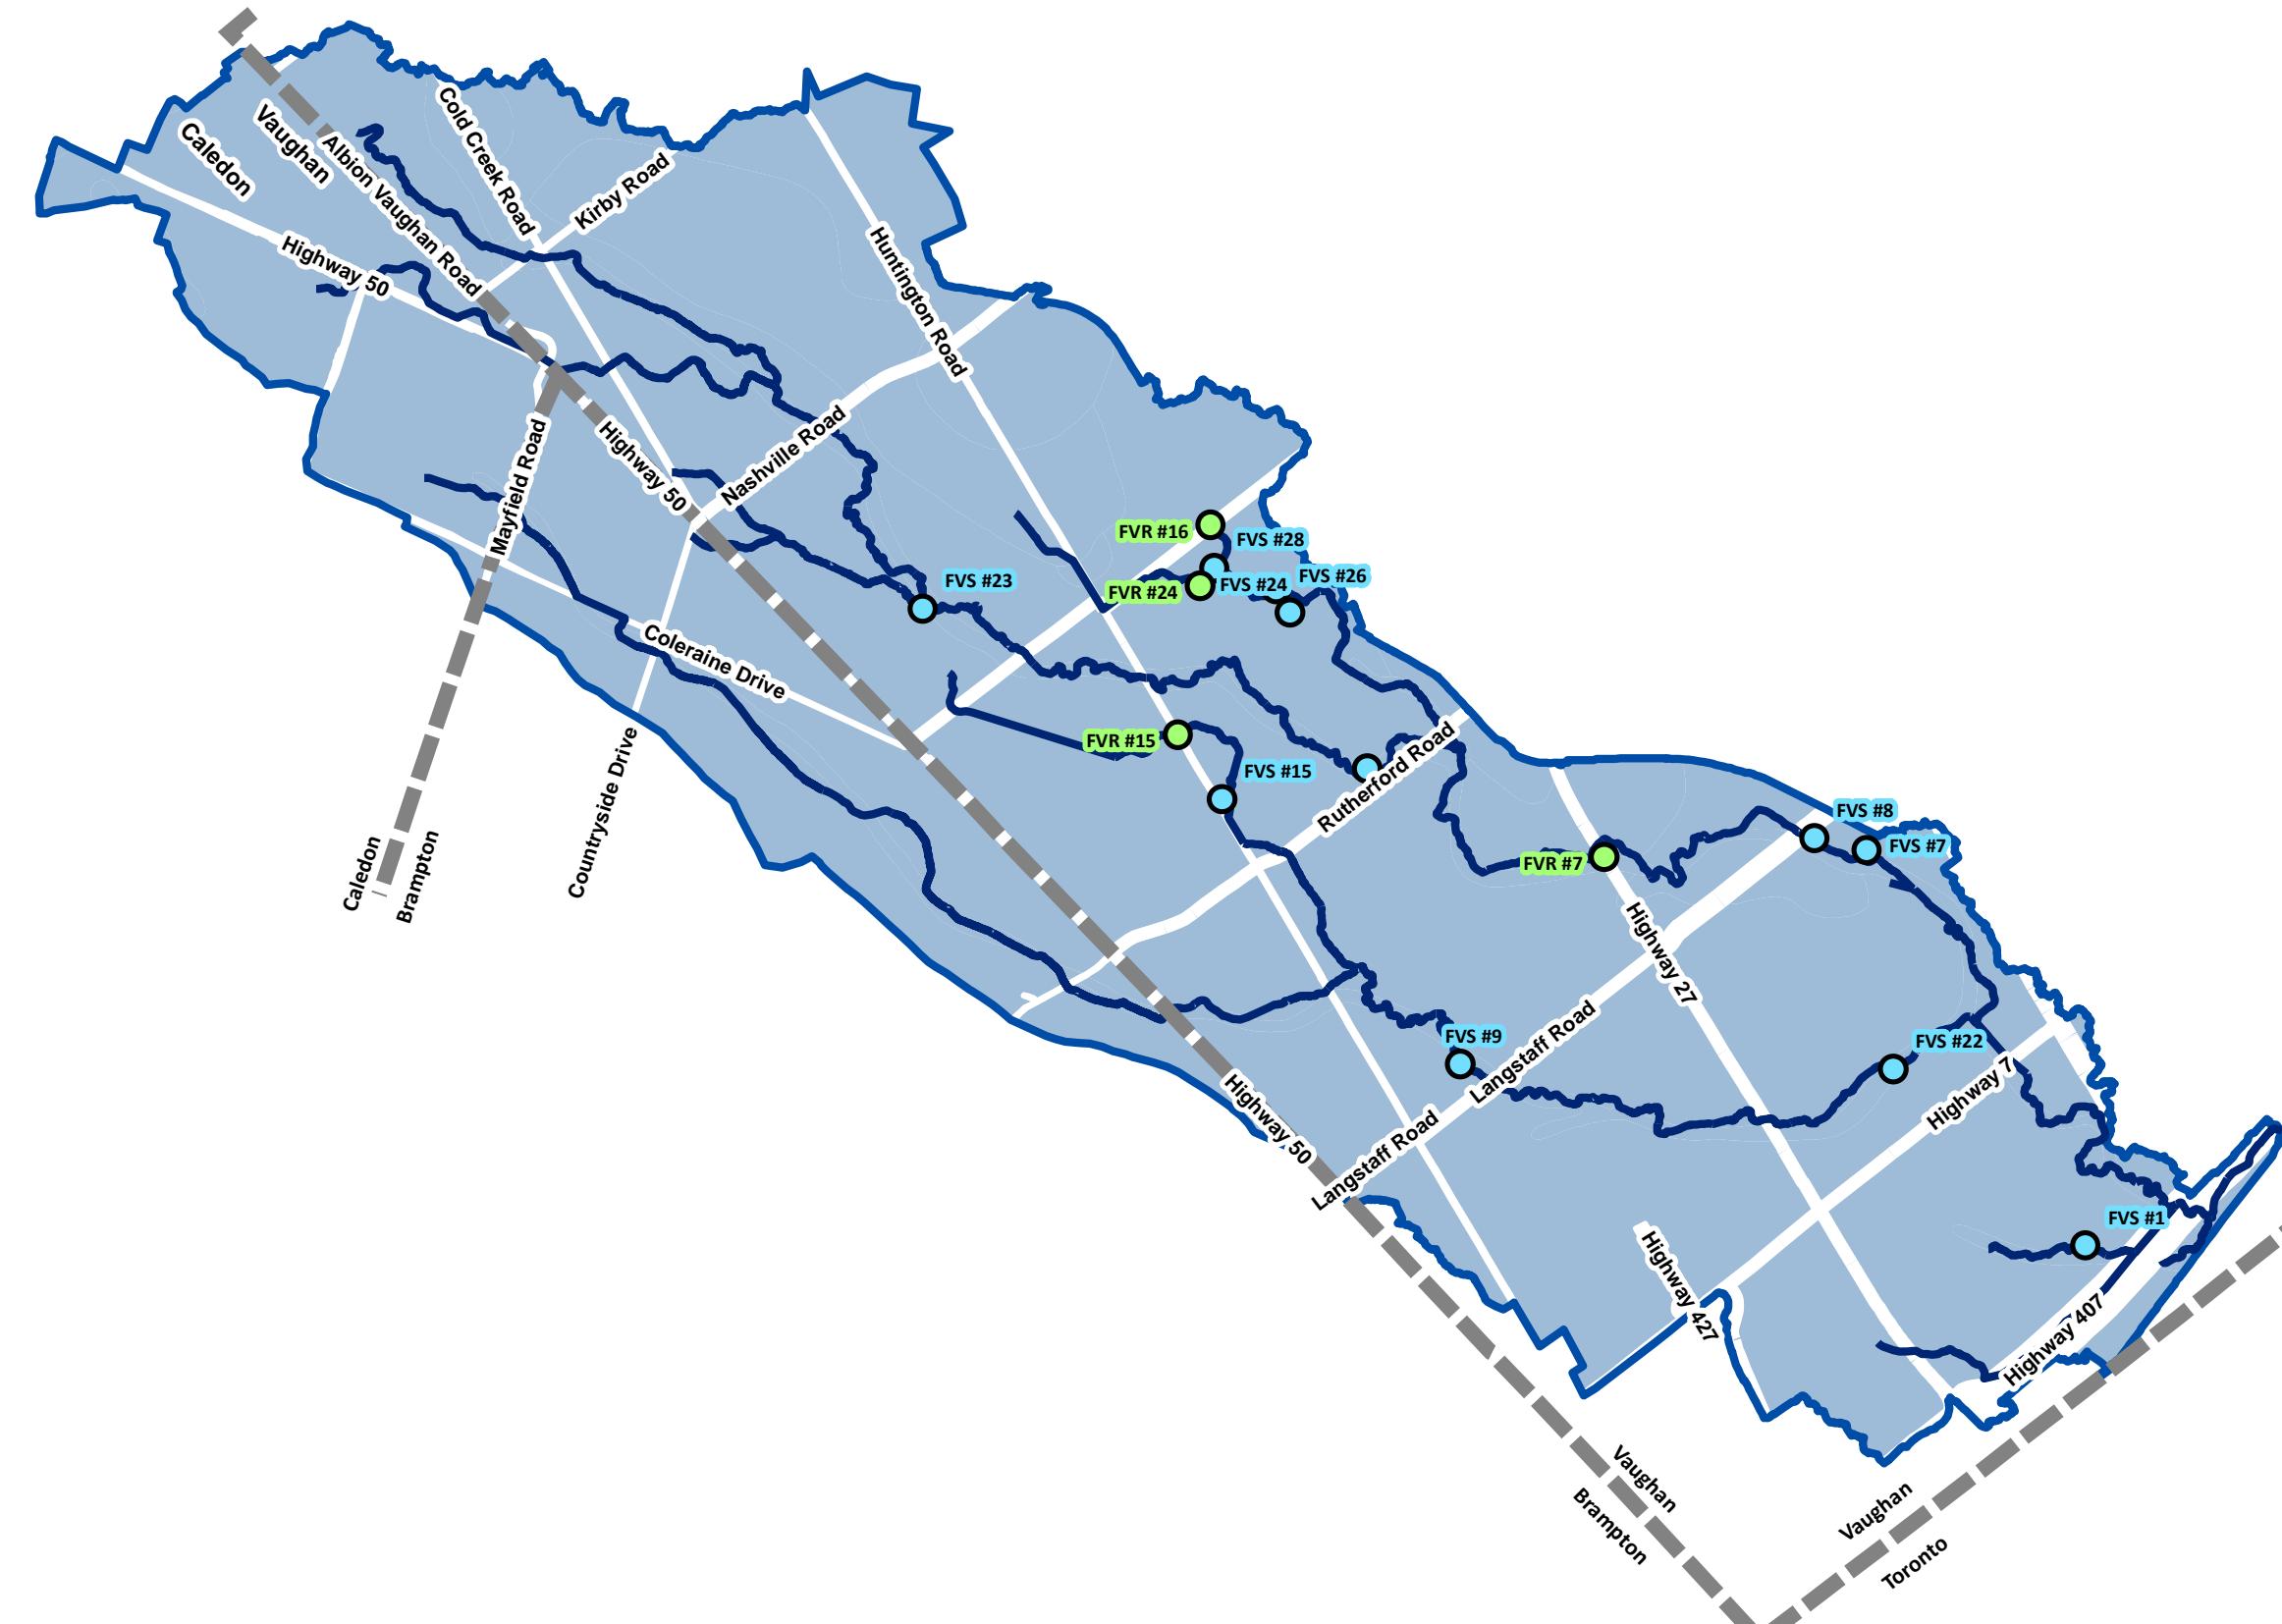
# Recommended Flood Works

Most of the recommendations made for flood vulnerable sites with a higher level of risk or an increase in flooding include a detailed survey to determine the extent of flooding. These studies are required because the DEM does not represent current grading in some areas of Rainbow Creek. We have updated the modeling surface with information provided by the City, but as built survey information was not available for all the sites and grading may have been changed on private properties. We have identified areas that appear to be at risk of flooding; however it is recommended that a study to determine the extent of the flood risk be completed for each of these sites prior to implementing solutions for flooding. **Table 5.6** below contains a summary of the recommendations and estimated costs for studies and flood remediation works, the locations of these recommended works are shown on **Figure-RW1** following the report.
