**Huntingdon Road
Vaughan, ON**

**Fluvial Geomorphological
Assessment
and
Meander Beltwidth
Assessment**

August 21, 2017

**RE: Huntingdon Road, Region of York, ON
 Fluvial Geomorphological Assessment and Meander Beltwidth Assessment**

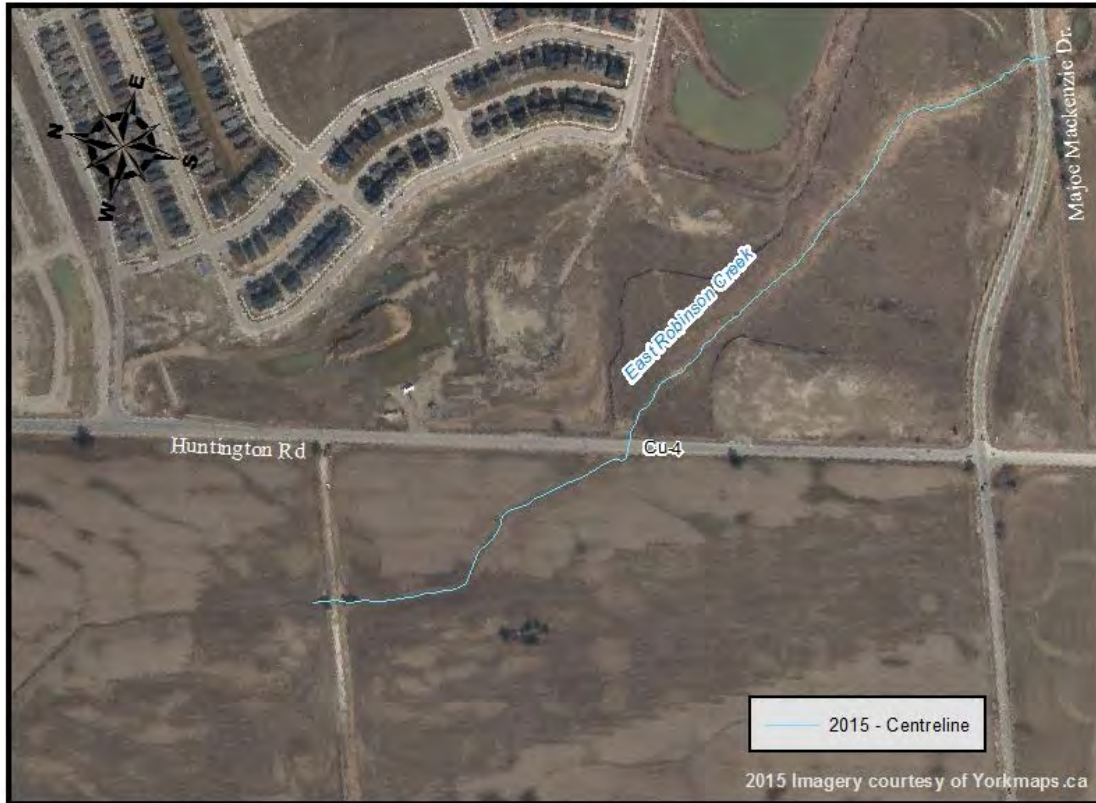
Figure 3: Aerial View of Cu-4 on East Robinson Creek

A small depression collects field runoff and crosses Huntingdon Rd at Cu-4 (see Figure 3). The channel lining is vegetated with grasses. The bed slope is 0.003 m/m. The average bankfull width and mean bankfull depth of the channel was determined to be 1.66 m and 0.03 m, respectively.

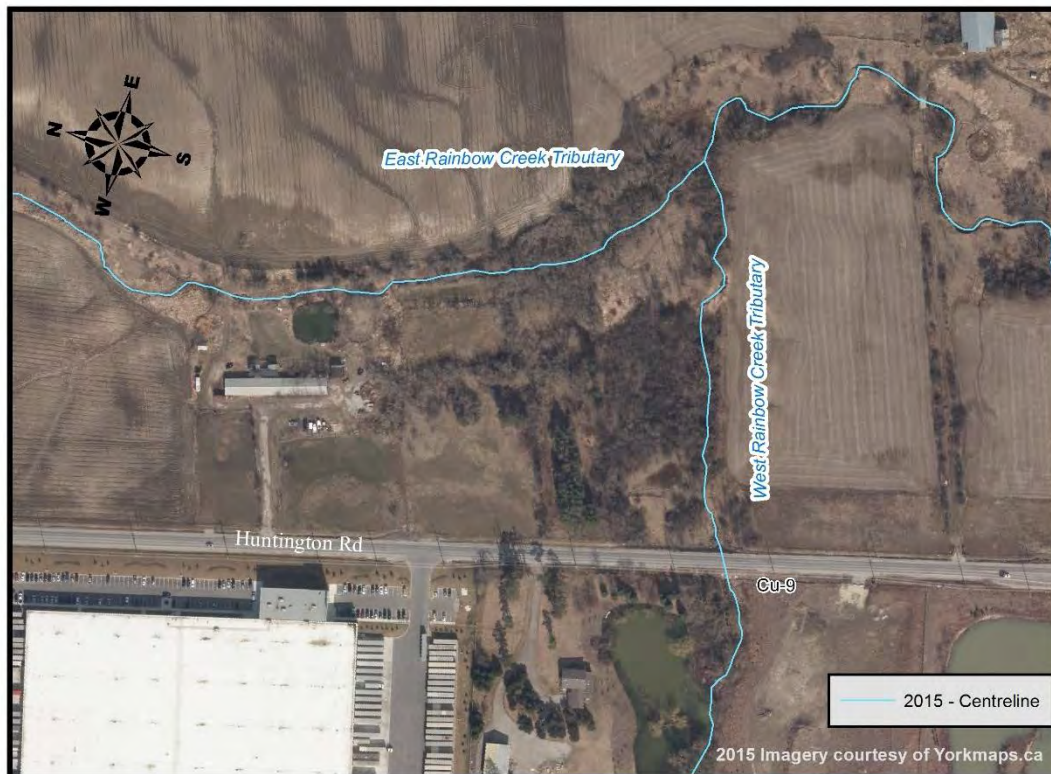
Figure 6: Aerial View of Cu-9 on West Rainbow Creek

This crossing is south of Rutherford Rd (See Figure 6). This culvert conveys West Rainbow Creek through Huntingdon Rd. The upstream reach shows good C channel features which changes to an E channel just upstream of the culvert. The downstream reach starts as an E channel and moves into a C channel further downstream. The upstream and downstream reaches have a good riparian zone with areas of trees and grasses.

Approximately 210 metres of the channel at this crossing was surveyed for this study. Three cross sections were also surveyed in this reach. The channel has a high width-to-depth ratio (>12) and is slightly entrenched. The average bankfull slope is 0.0078 m/m, and the bankfull width and average depth were noted to be 2.81 m and 0.23 m. The substrate in this reach contains sands and gravels but also contains a larger percentage of cobbles. A sieve sample was completed for the reach and the results show 7% sands and 63% gravels and 30% cobbles. A Rosgen classification of C4 has been given to this channel. Survey results can be seen in Table 1.

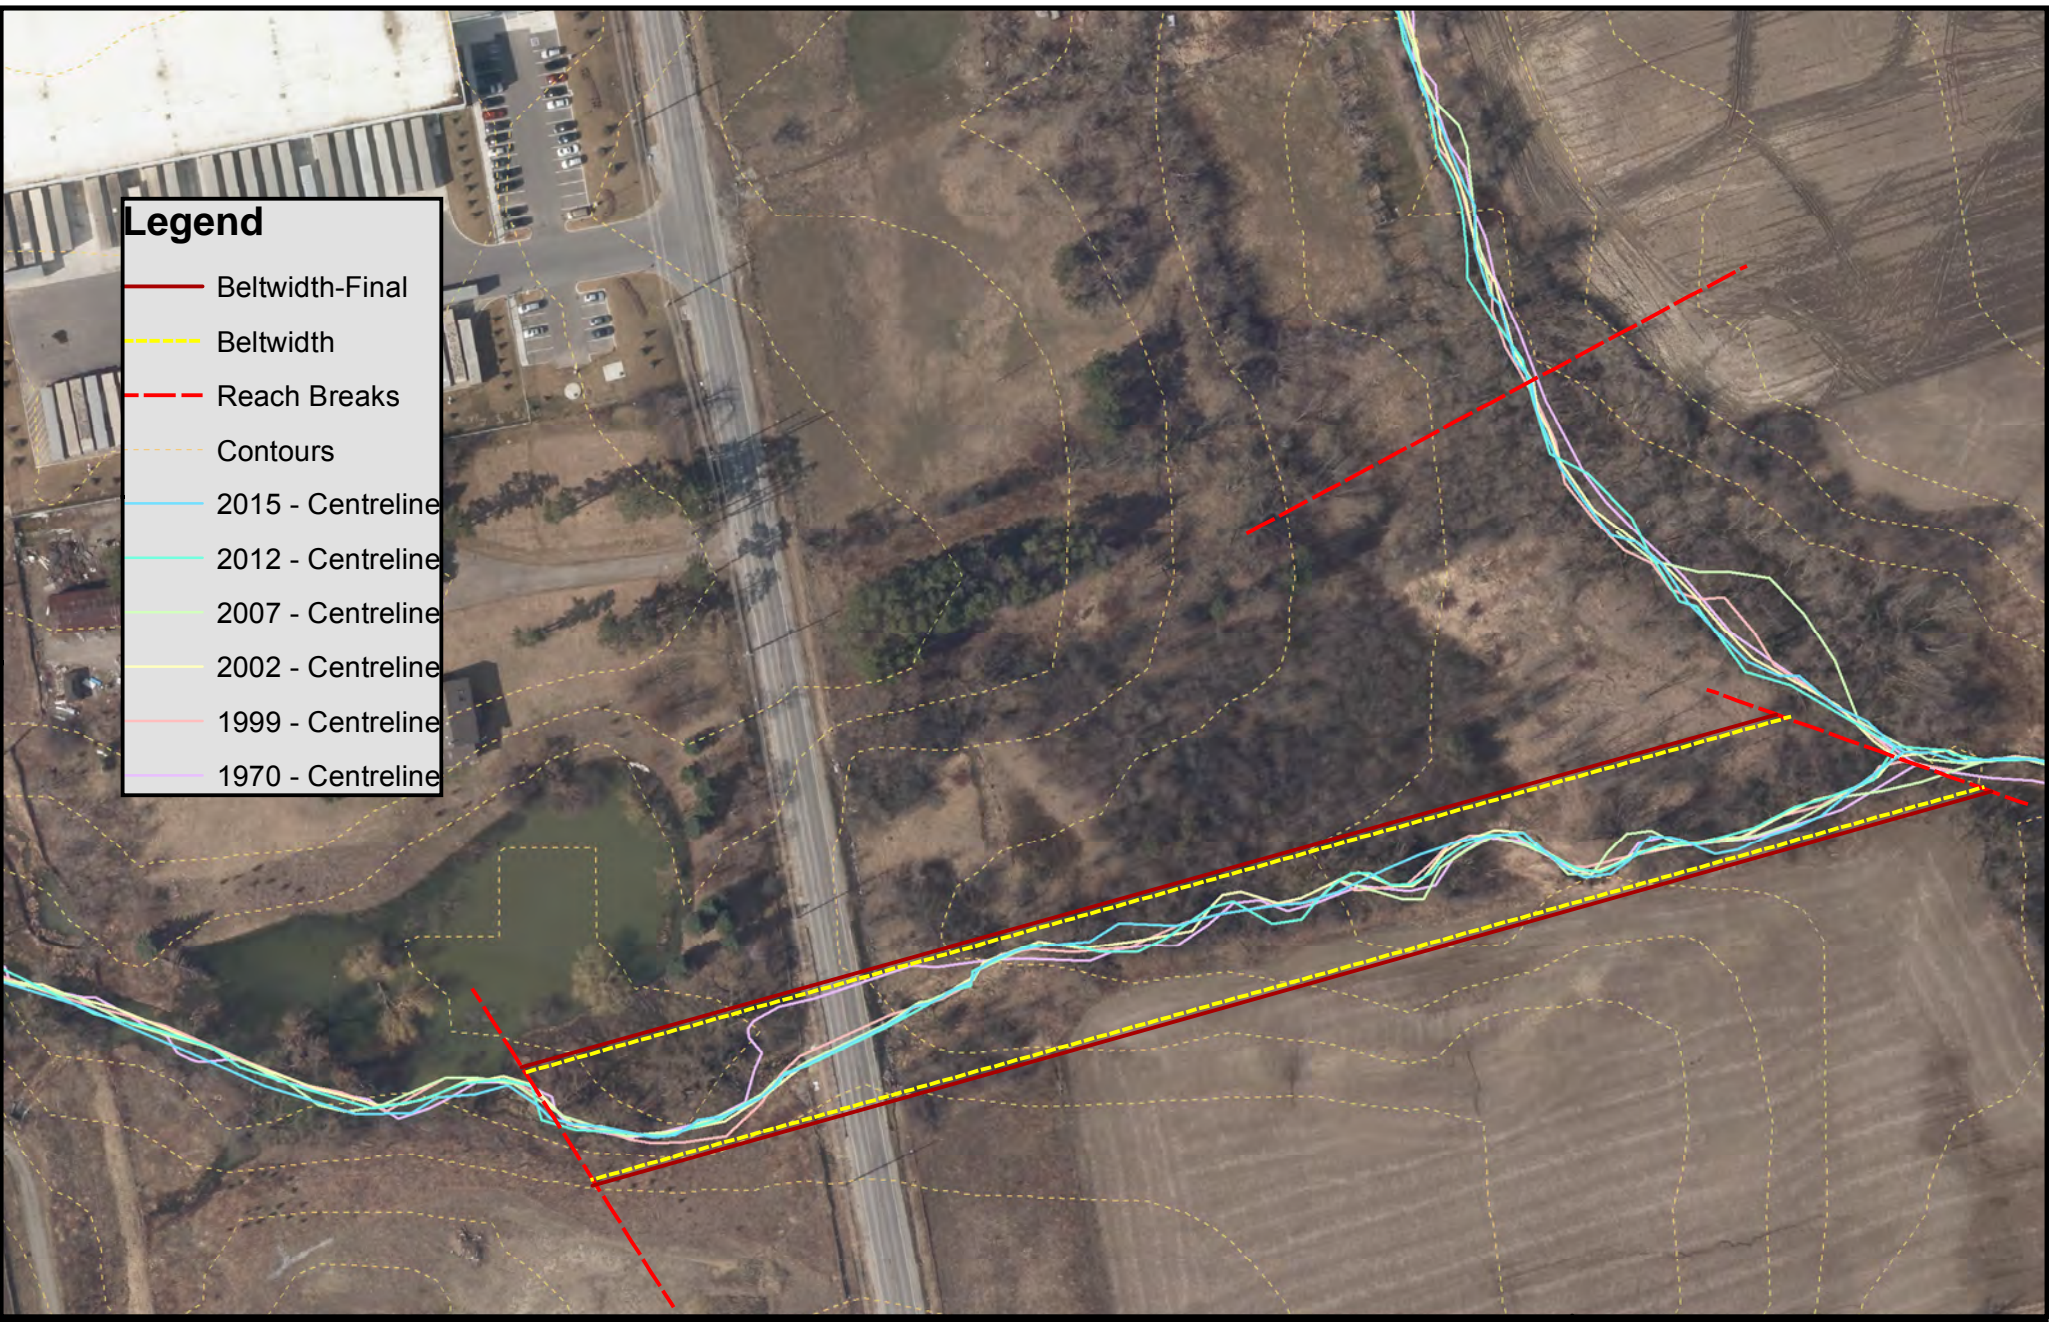
<h3>Huntington Road</h3> <p>Vaughan, Ontario</p>	Figure No.:	Date:
	12	May 31, 2016
<p>Proposed Realignment (Conceptual)</p>	Checked By:	Drawn By:
	EG	CB

In order to facilitate the road widening works, it is essential that reach ER-5 of East Rainbow Creek that at present runs alongside the Huntington Road be realigned. A conceptual plan (shown in Figure 13) is proposed. Following are its salient features:

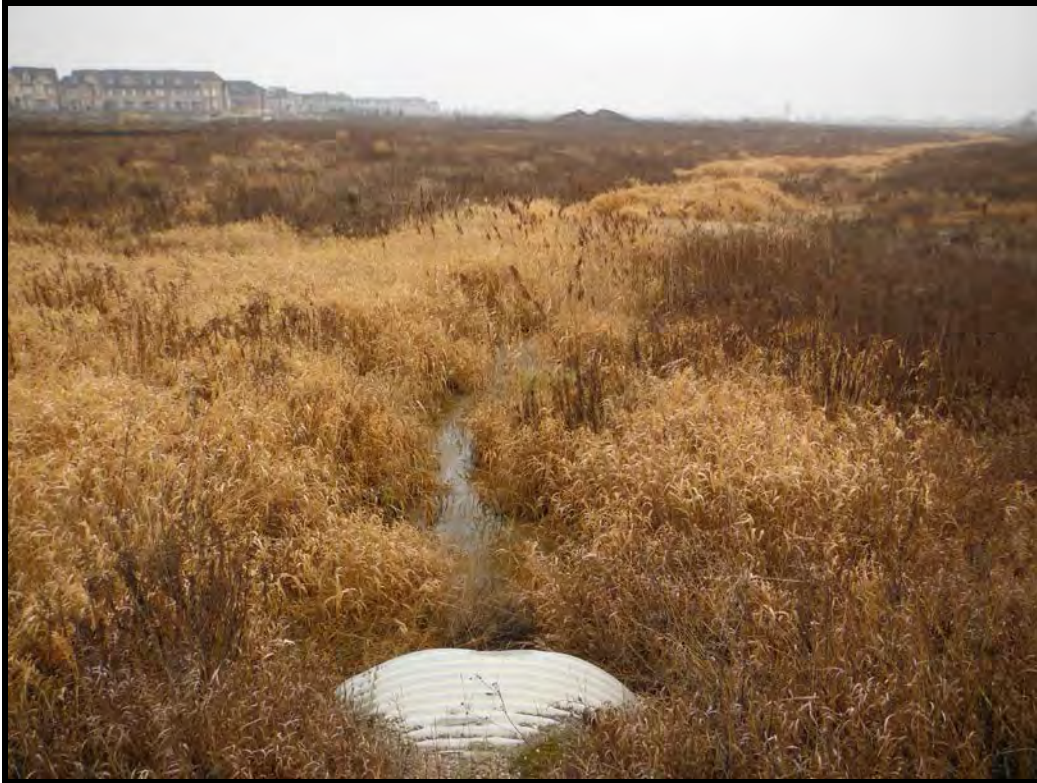
PHOTOGRAPH NO.: 1 – Culvert 4
FROM: Huntington Road
LOOKING: Downstream
COMMENT: East Robinson Creek

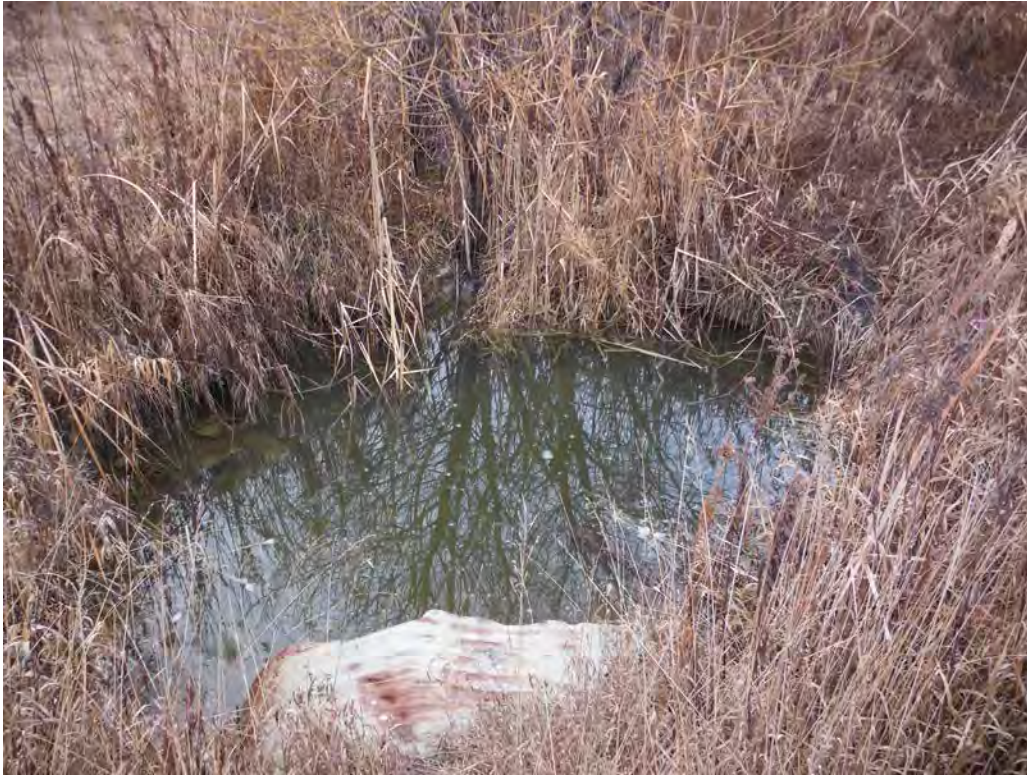
PHOTOGRAPH NO.: 13 - Culvert 7
FROM: Huntington Road
LOOKING: Upstream of Culvert
COMMENT: Rainbow Creek

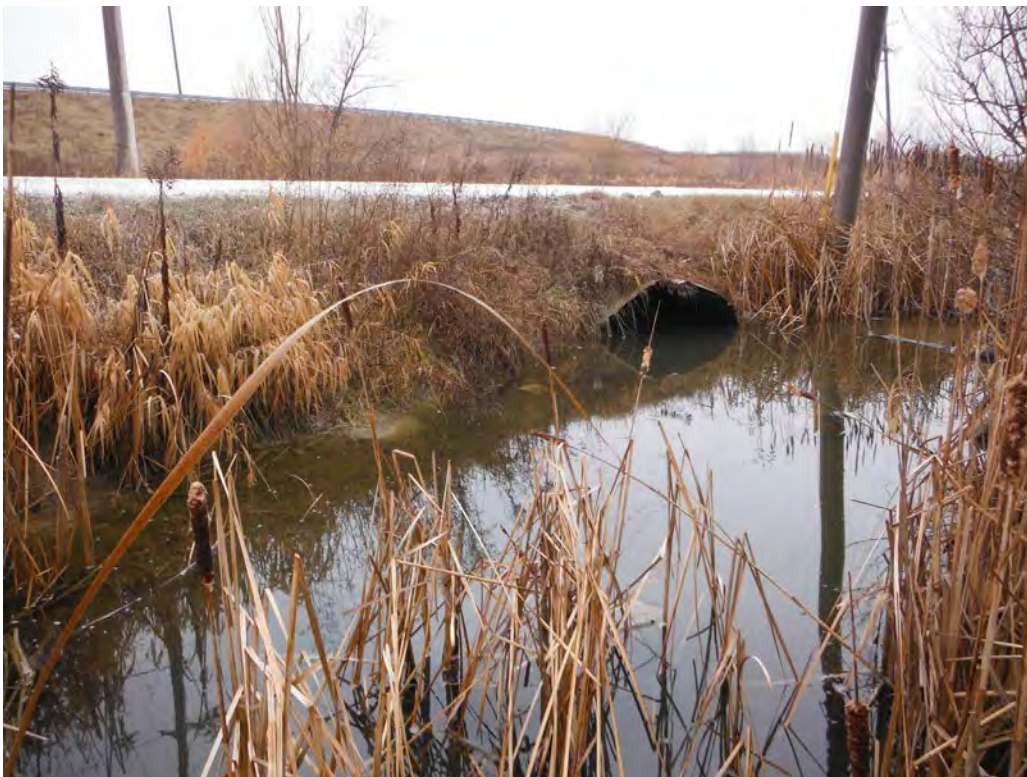
PHOTOGRAPH NO.: 14 - Culvert 7
FROM: Huntington Road
LOOKING: Downstream of Culvert
COMMENT: Rainbow Creek Tributary

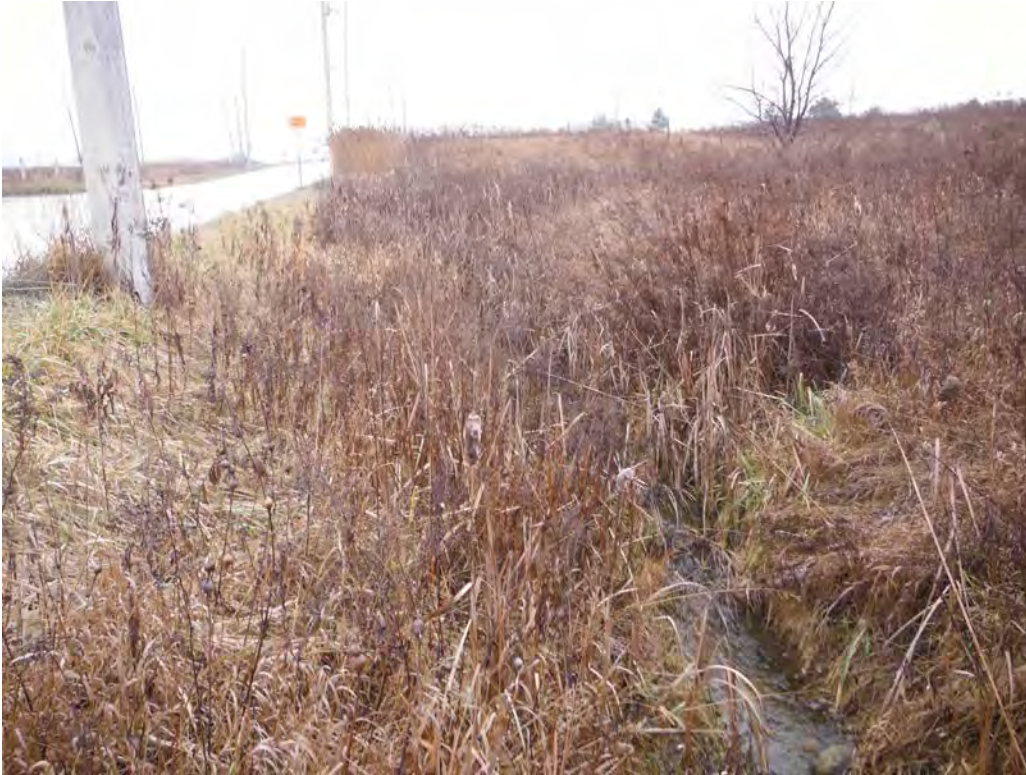
PHOTOGRAPH NO.: 15
FROM: Top of Bank on Channel on the west of Huntington Road
LOOKING: Downstream of Culvert 7 at south channel
COMMENT: Rainbow Creek Tributary
